Historic Preservation Application

## WINDOW ASSESSMENT FORM

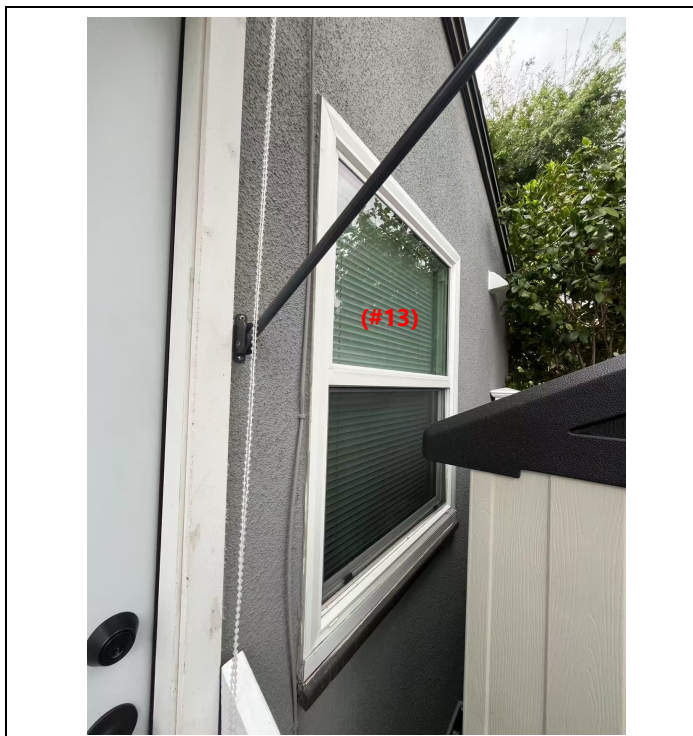
North side windows of the main house dwelling.

(1) W 3'-3" x H 4'-0" Single Hung

x Deteriorated to point of being dangerous

The previous wood windows were infested by termites, and they were damaged. Therefore, the previous owner replaced the damaged windows with vinyl materials and wood covered with stucco decorative molding to match the previous windows' style. Also, the previous owner said she has already applied the application and paid for the city's fees for the replacement, so the windows should be legal.

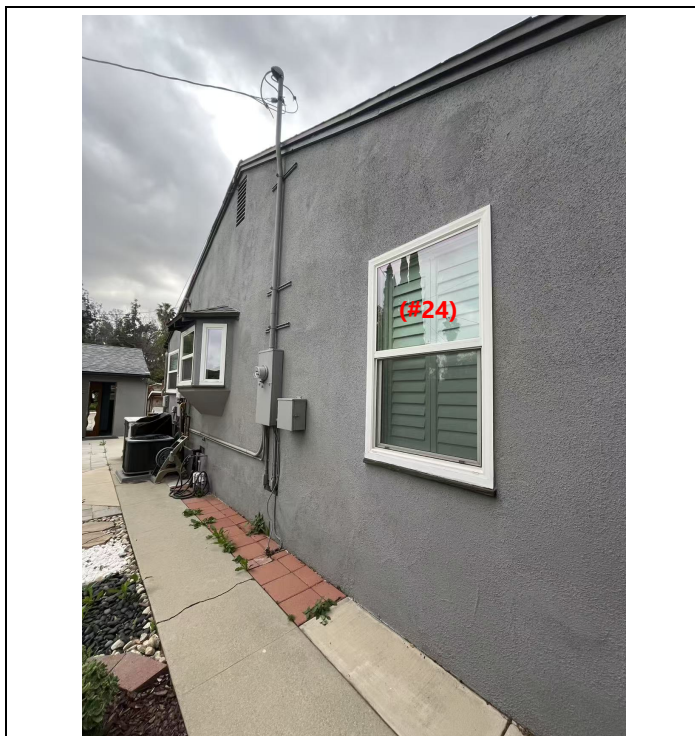
South side windows of the main house dwelling.

(1) W 3'-0" x H 5'-0" Single Hung

x Deteriorated to point of being dangerous

The previous wood windows were infested by termites, and they were damaged. Therefore, the previous owner replaced the damaged windows with vinyl materials and wood covered with stucco decorative molding to match the previous windows' style. Also, the previous owner said she has already applied the application and paid for the city's fees for the replacement, so the windows should be legal.

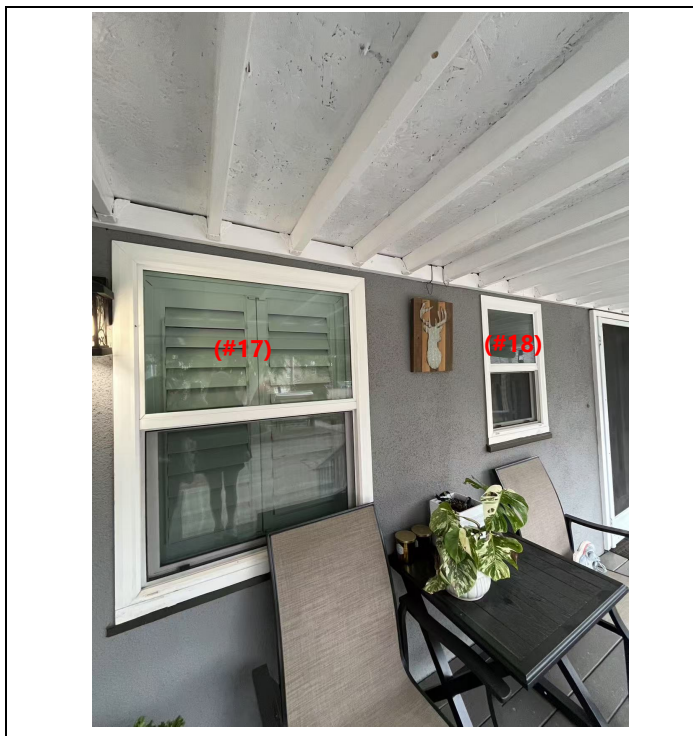
West side windows of the main house dwelling.

(1) W 3'-3" x H 4'-0" Single Hung (#17)

(1) W 2'-3" x H 3'-3" Single Hung (#18)

\_\_\_ Excellent \_\_\_ Good \_\_\_ Fair \_\_\_ Poor x Deteriorated to point of being dangerous

The previous wood windows were infested by termites, and they were damaged. Therefore, the previous owner replaced the damaged windows with vinyl materials and wood covered with stucco decorative molding to match the previous windows' style. Also, the previous owner said she has already applied the application and paid for the city's fees for the replacement, so the windows should be legal.
