Rehabilitation Plan Photos

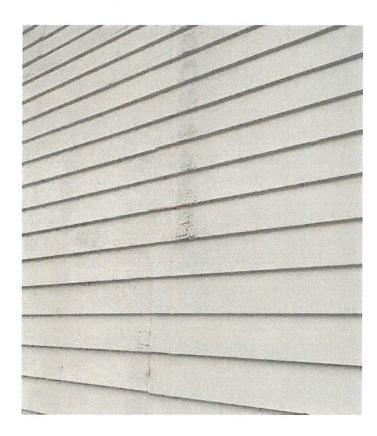
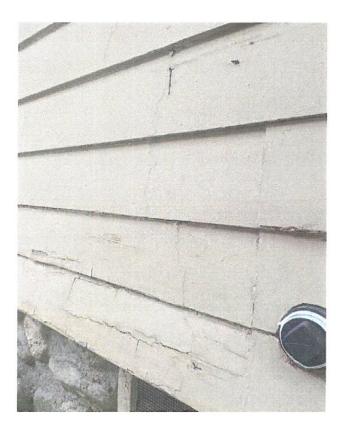
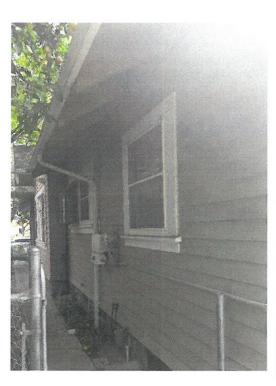
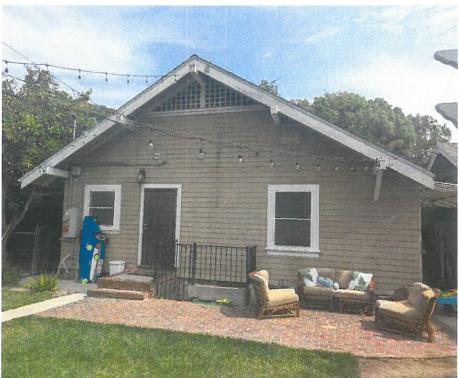
Exterior Paint—our current paint job is at least 11 years old and most likely 17 years old, parts are chipping and peeling, the whole thing will need to be repainted.

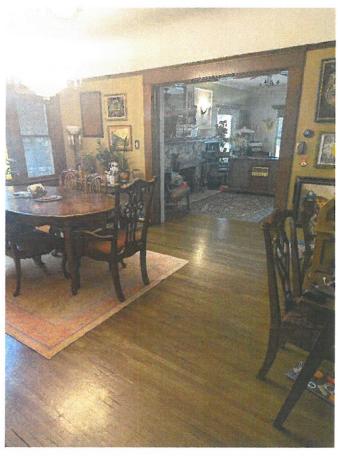
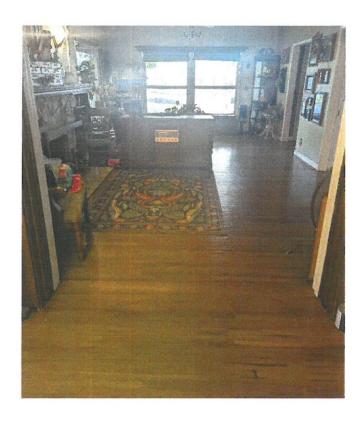
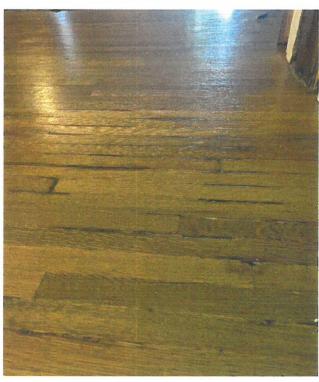
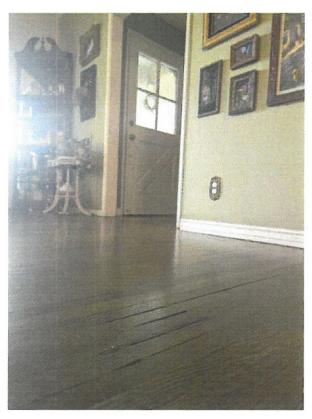
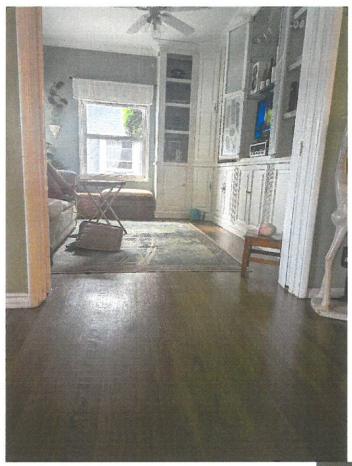
Floor Refinishing

We originally had the floors sanded in 2014 and were told that this was the last time we could do it. They have since continued to splinter with their tongue/groove installation. We need to recoat them with polyeurthane, patch them with epoxy, and buff/polish them again. Dining room, living room, and parlor.

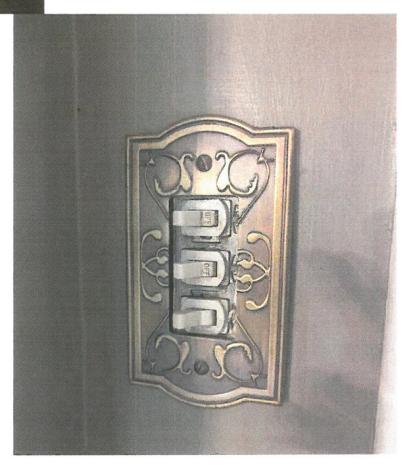
Electrical—I can't take pictures of all the faulty wiring, but there's some old knob and Tube and much of the house is cloth. There have been some close calls as the cloth disintegrates, and 2/3 of the house needs to be rewired. Here's a pic of an old switch that sometimes works and sometimes gets stuck before clacking over.
