Historic Preservation Application

WINDOW ASSESSMENT FORM

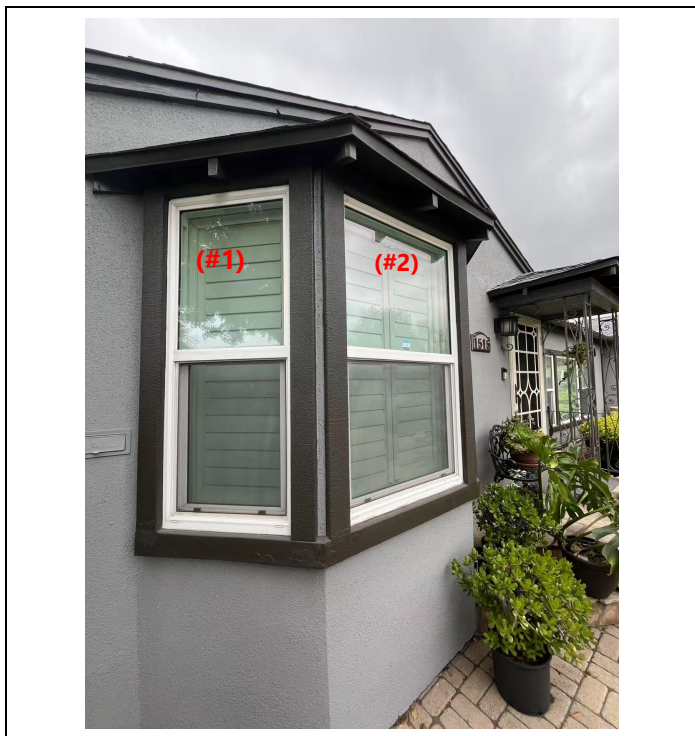
East side windows that near the front door of the main
house dwelling.

(2) W 2'-0" x H 5'-0" Single Hung (#1) (#3)

(1) W 3'-0" x H 5'-0" Single Hung (#2)

☐ Excellent ☐ Good ☐ Fair ☐ Poor ☒ Deteriorated to point of being dangerous

The previous wood windows were infested by termites, and they were damaged. Therefore, the previous owner replaced the damaged windows with vinyl materials and wood covered with stucco decorative molding to match the previous windows' style. Also, the previous owner said she has already applied the application and paid for the city's fees for the replacement, so the windows should be legal.

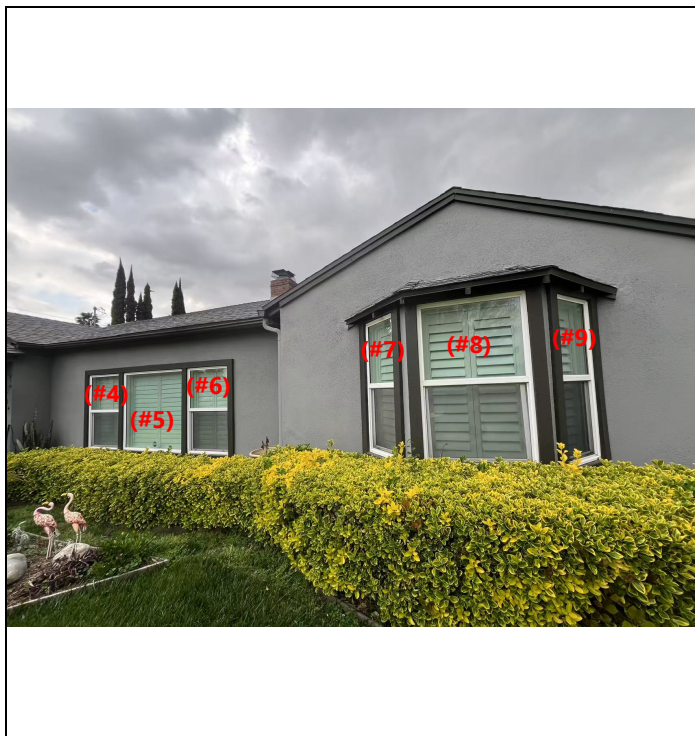
East side windows that near the front door of the main
house dwelling.

(1) W 5'-0" x H 5'-0" Fixed Window **(#5)**

(2) W 2'-0" x H 5'-0" Single Hung **(#7) (#9)**

(3) W 3'-0" x H 5'-0" Single Hung **(#4) (#6) (#8)**

☐ Excellent ☐ Good ☐ Fair ☐ Poor ☒ Deteriorated to point of being dangerous

The previous wood windows were infested by termites, and they were damaged. Therefore, the previous owner replaced the damaged windows with vinyl materials and wood covered with stucco decorative molding to match the previous windows' style. Also, the previous owner said she has already applied the application and paid for the city's fees for the replacement, so the windows should be legal.

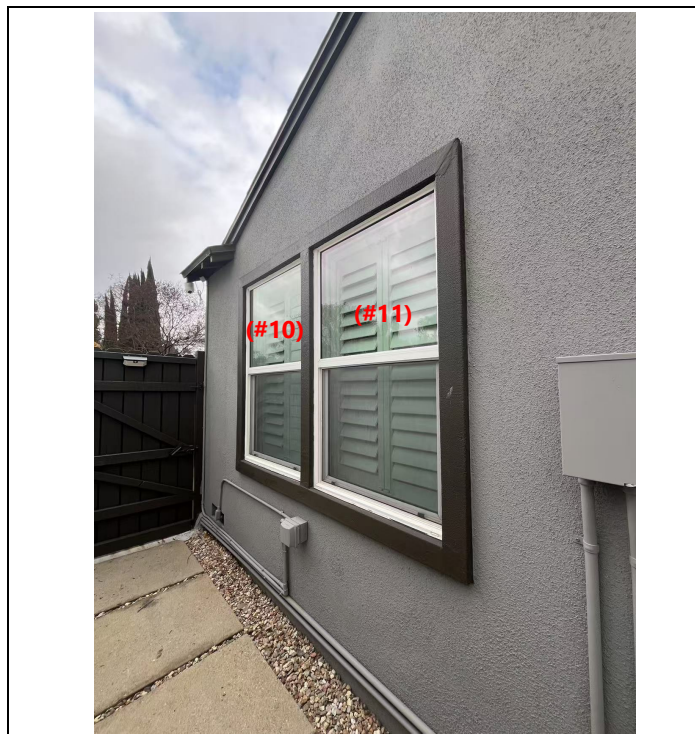
North side windows of the main house dwelling.

(2) W 3'-0" x H 5'-0" Single Hung **(#10) (#11)**

☐ Excellent ☐ Good ☐ Fair ☐ Poor ☒ Deteriorated to point of being dangerous

The previous wood windows were infested by termites, and they were damaged. Therefore, the previous owner replaced the damaged windows with vinyl materials and wood covered with stucco decorative molding to match the previous windows' style. Also, the previous owner said she has already applied the application and paid for the city's fees for the replacement, so the windows should be legal.

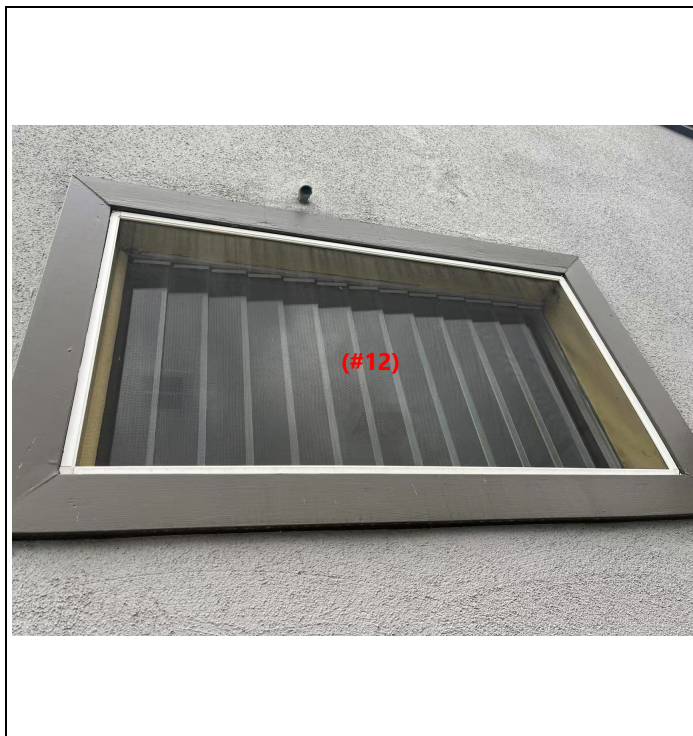
North side windows of the main house dwelling.

(1) W 4'-0" x H 2'-2" Screen Window

x Deteriorated to point of being dangerous

The previous wood windows were infested by termites, and they were damaged. Therefore, the previous owner replaced the damaged windows with vinyl materials and wood covered with stucco decorative molding to match the previous windows' style. Also, the previous owner said she has already applied the application and paid for the city's fees for the replacement, so the windows should be legal.

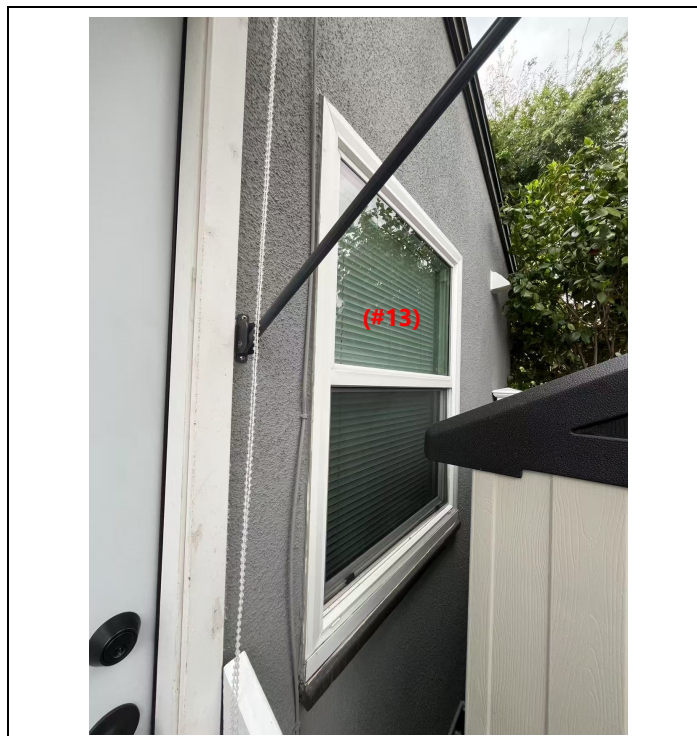
North side windows of the main house dwelling.

(1) W 3'-3" x H 4'-0" Single Hung

x Deteriorated to point of being dangerous

The previous wood windows were infested by termites, and they were damaged. Therefore, the previous owner replaced the damaged windows with vinyl materials and wood covered with stucco decorative molding to match the previous windows' style. Also, the previous owner said she has already applied the application and paid for the city's fees for the replacement, so the windows should be legal.

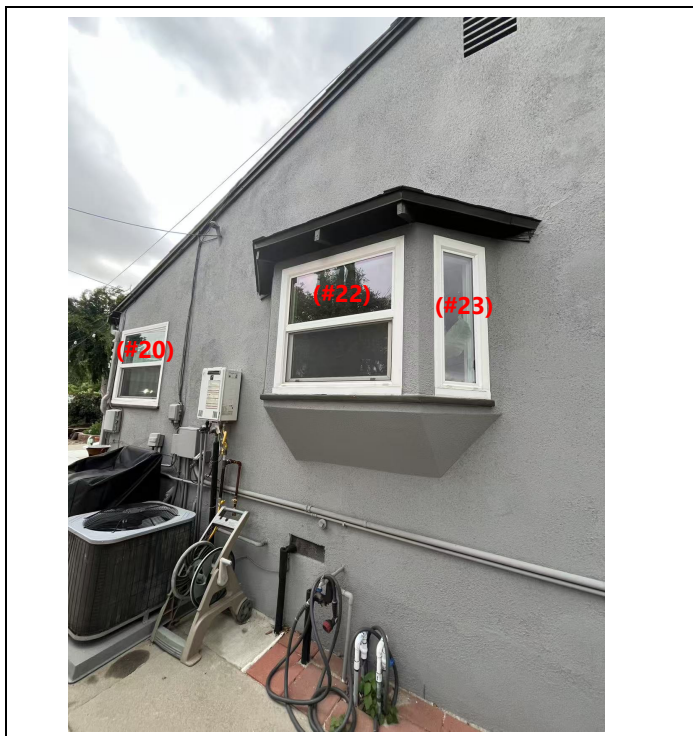
South side windows of the main house dwelling.

(1) W 4'-3" x H 3'-8" Single Hung (#20)

(1) W 3'-3" x H 3'-3" Single Hung (#22)

(2) W 1'-3" x H 3'-3" Fixed Window (#21) (#23)

___ Excellent ___ Good ___ Fair ___ Poor x Deteriorated to point of being dangerous

The previous wood windows were infested by termites, and they were damaged. Therefore, the previous owner replaced the damaged windows with vinyl materials and wood covered with stucco decorative molding to match the previous windows' style. Also, the previous owner said she has already applied the application and paid for the city's fees for the replacement, so the windows should be legal.

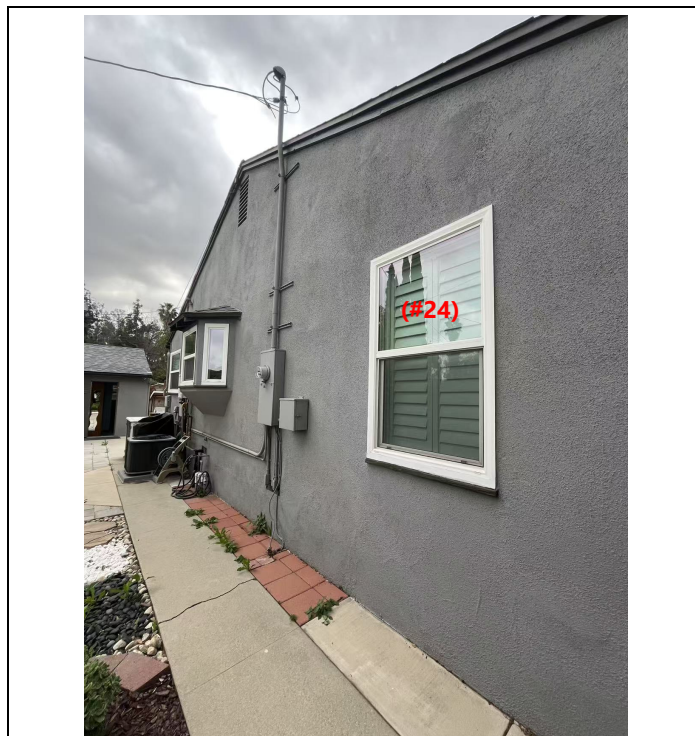
South side windows of the main house dwelling.

(1) W 3'-0" x H 5'-0" Single Hung (#24)

☐ Excellent ☐ Good ☐ Fair ☐ Poor ☒ Deteriorated to point of being dangerous

The previous wood windows were infested by termites, and they were damaged. Therefore, the previous owner replaced the damaged windows with vinyl materials and wood covered with stucco decorative molding to match the previous windows' style. Also, the previous owner said she has already applied the application and paid for the city's fees for the replacement, so the windows should be legal.

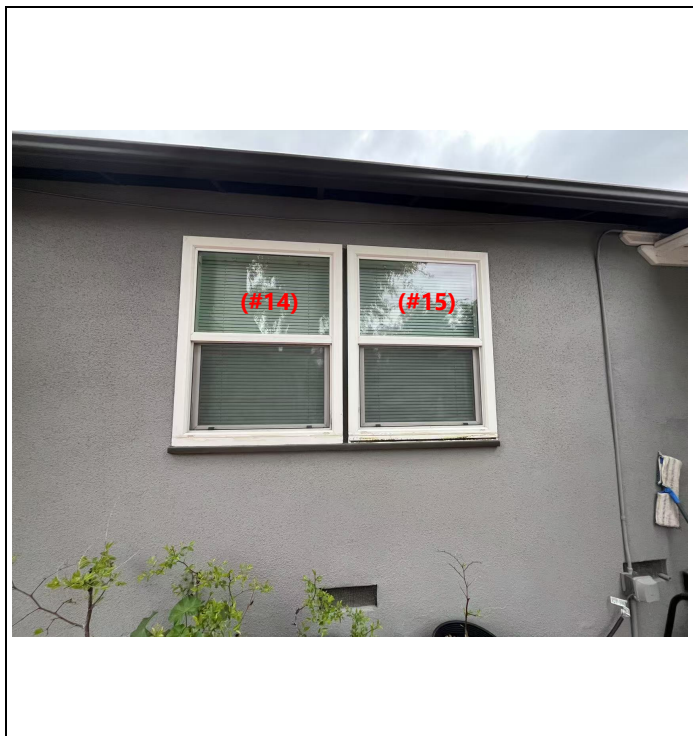
West side windows of the main house dwelling.

(2) W 3'-3" x H 4'-0" Single Hung

x Deteriorated to point of being dangerous

The previous wood windows were infested by termites, and they were damaged. Therefore, the previous owner replaced the damaged windows with vinyl materials and wood covered with stucco decorative molding to match the previous windows' style. Also, the previous owner said she has already applied the application and paid for the city's fees for the replacement, so the windows should be legal.

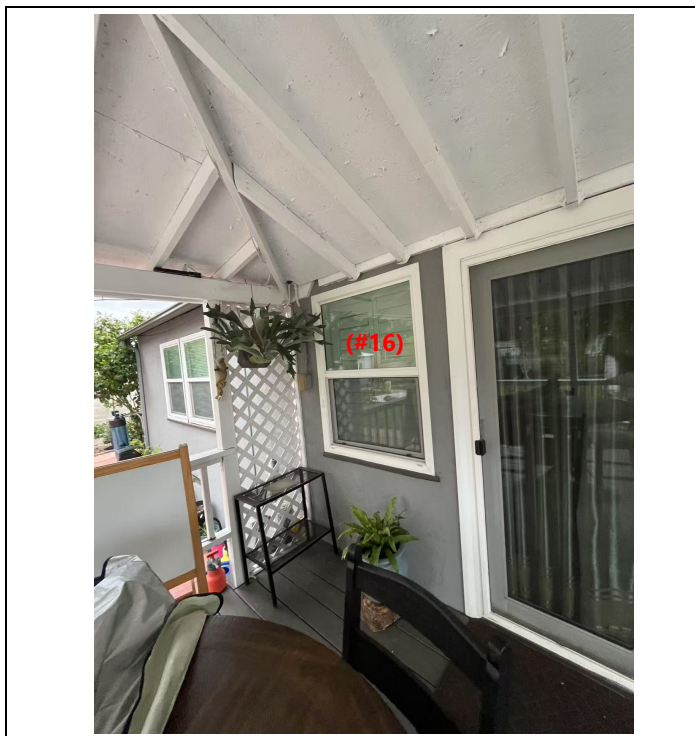
West side windows of the main house dwelling.

(1) W 3'-3" x H 4'-0" Single Hung

x Deteriorated to point of being dangerous

The previous wood windows were infested by termites, and they were damaged. Therefore, the previous owner replaced the damaged windows with vinyl materials and wood covered with stucco decorative molding to match the previous windows' style. Also, the previous owner said she has already applied the application and paid for the city's fees for the replacement, so the windows should be legal.

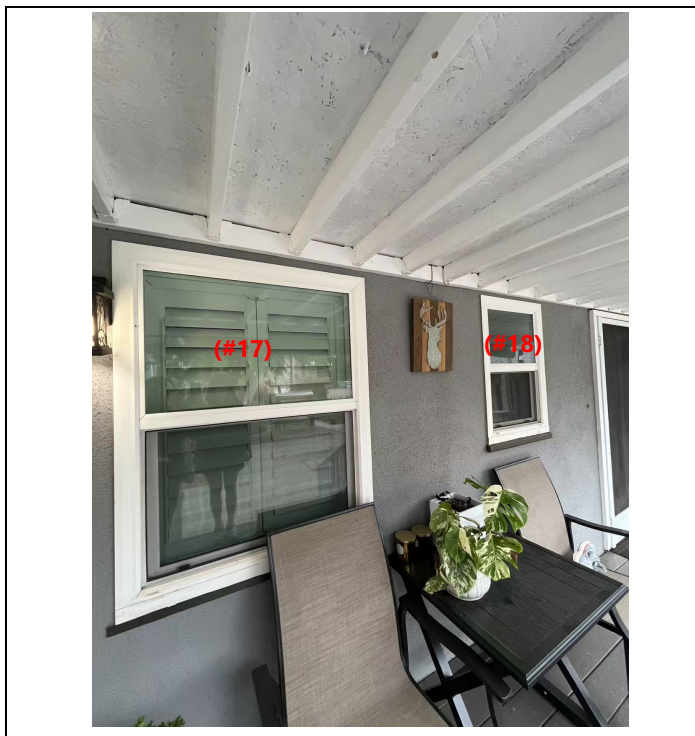
West side windows of the main house dwelling.

(1) W 3'-3" x H 4'-0" Single Hung (#17)

(1) W 2'-3" x H 3'-3" Single Hung (#18)

___ Excellent ___ Good ___ Fair ___ Poor x Deteriorated to point of being dangerous

The previous wood windows were infested by termites, and they were damaged. Therefore, the previous owner replaced the damaged windows with vinyl materials and wood covered with stucco decorative molding to match the previous windows' style. Also, the previous owner said she has already applied the application and paid for the city's fees for the replacement, so the windows should be legal.

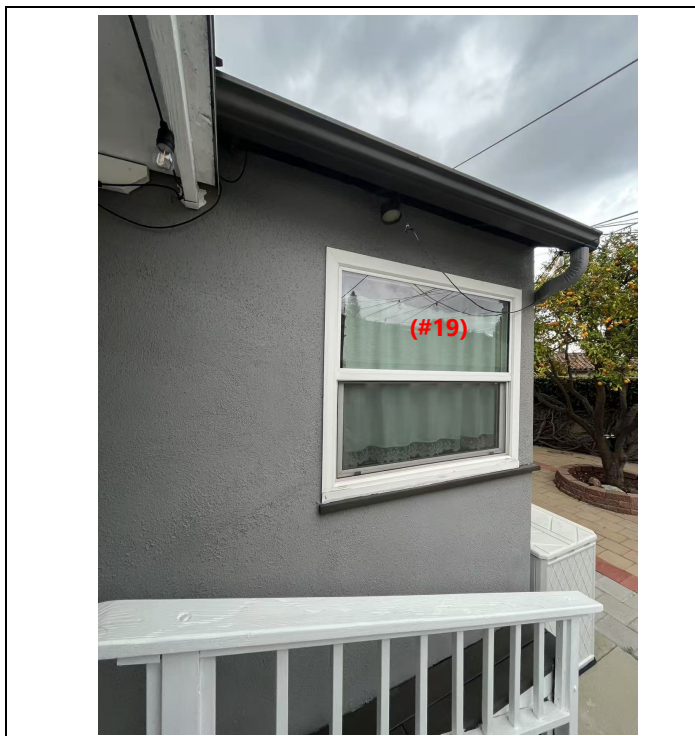
West side windows of the main house dwelling.

(1) W 4'-3" x H 3'-8" Single Hung

x Deteriorated to point of being dangerous

The previous wood windows were infested by termites, and they were damaged. Therefore, the previous owner replaced the damaged windows with vinyl materials and wood covered with stucco decorative molding to match the previous windows' style. Also, the previous owner said she has already applied the application and paid for the city's fees for the replacement, so the windows should be legal.
