CITY OF POMONA
Historic Resources Inventory
(Short Form - Exterior)

(1) Address: 355 CHESTER PL (2) Neighborhood: _____

*Resource Name or #: (Assigned by Recorder) 355 W Chester Place

P1. Other Identifier Wilton Heights Historic District

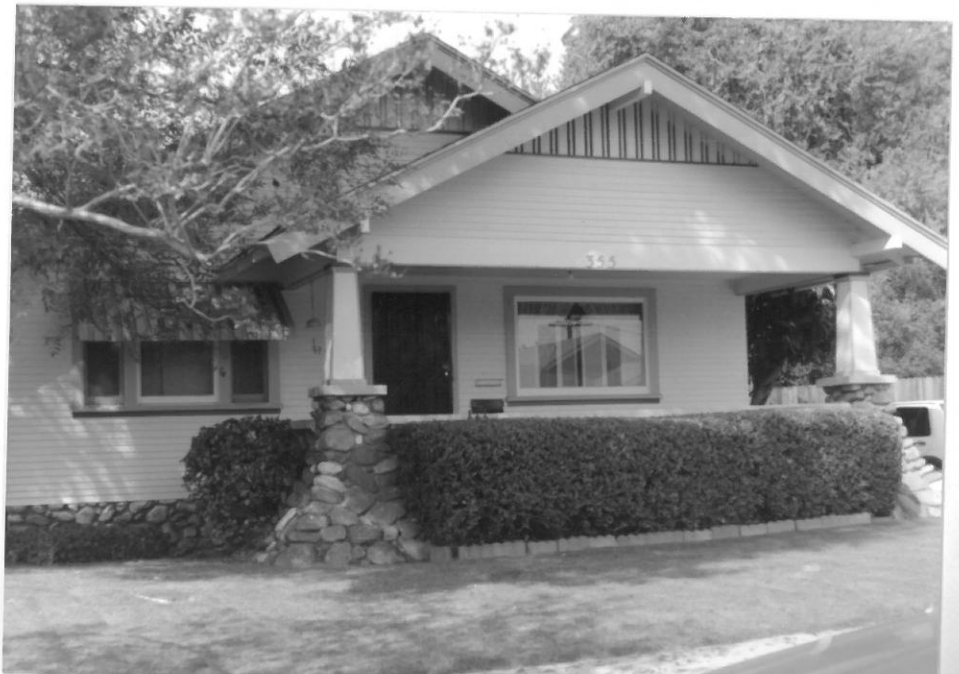
(5) Estimated Construction Date(s): 1921 (6) Condition of Structure GOOD

Description: AWNINGS

(8) Other comments or observations: NICE TAPERED ROCK PIERS

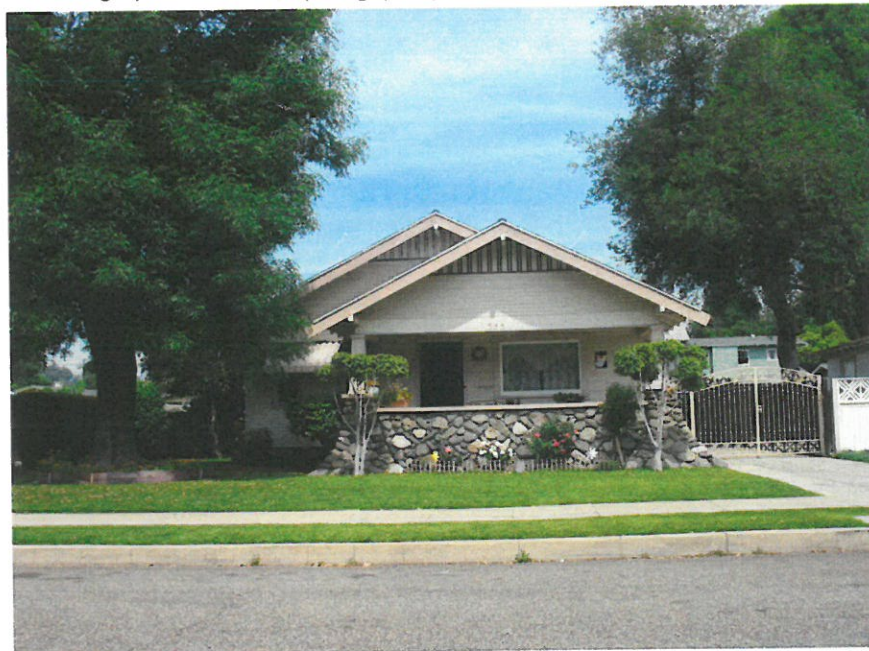
This building is a one-story, single-family residence constructed in the Craftsman Bungalow style in 1921. It has an irregular plan with an asymmetrical south-facing façade. The foundation is fieldstone. The wood frame structural system has an exterior cladding of horizontal wood boards. It is sheltered by a moderately pitched cross-gabled roof. The roof has overhanging eaves, exposed rafters, and verge boards. Wood vertical vents are located just underneath the gable pitch.

This building is characterized by a large porch that spans the right (east) portion of the front façade. It is sheltered by a secondary front-facing gable that projects from the building. The porch has concrete stairs and landing. The porch is supported by two tapered squared wood piers. The flared pier supports and porch railing are constructed of fieldstone. The- (--See Continuation Form--)

There have been minimal alterations made to the building, such as the addition of a metal awning to one of the front windows. Otherwise the house has been relatively unaltered and is in good to excellent condition. The integrity is good.
