**CITY OF POMONA**  
**Historic Resources Inventory**  
**(Short Form - Exterior)**

(1) Address: 490 PRECIADO (2) Neighborhood: \_\_\_\_\_

\*Resource Name or #: (Assigned by Recorder) 490 PRECIADO ST

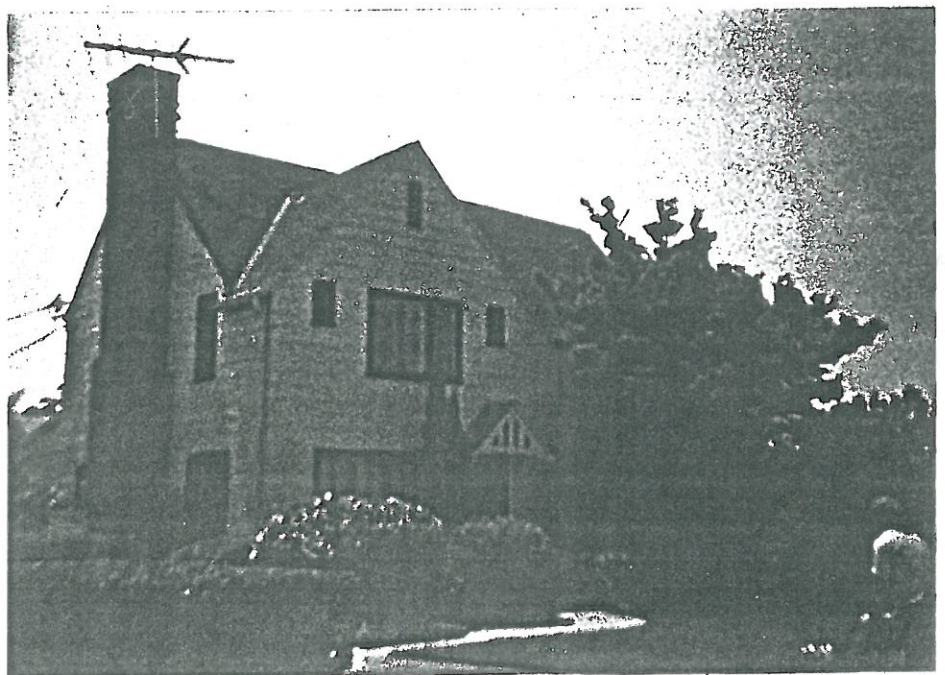
This 1926 home is identifiable as a Tudor Revival by its steeply pitched roof, dominant cross-front-gable, and multiple groups of multi-paned windows. It is uncommon to see clapboard siding in a Tudor home, but not unheard of. The original owner was a manager at the local Kerckhoff-Cuzner Mill, and perhaps this accounts for the redwood siding of the home.

Windows are casement window, which is also typical of the style with eight panes each. The second story features french doors.

The second story balcony is cantilevered and covered by the principle roof.

Garage is attached and located at the back of the house.

Some windows have been replaced on the west side of the house with aluminum framed windows in the 1950s.
