Restoration, Rehabilitation and Preservation Plan

james chertkow
337 san francisco ave
POMONA CA 91767

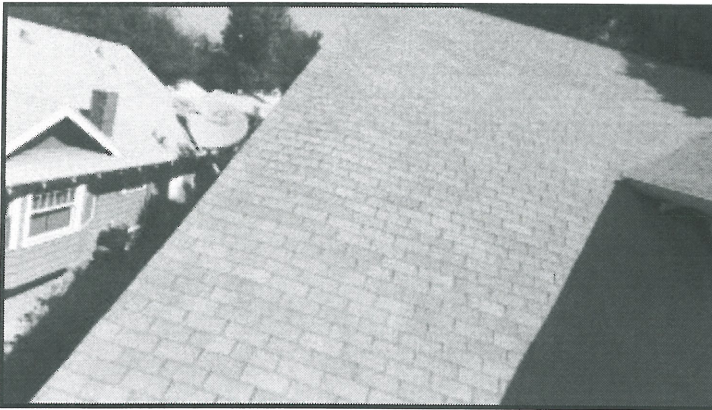
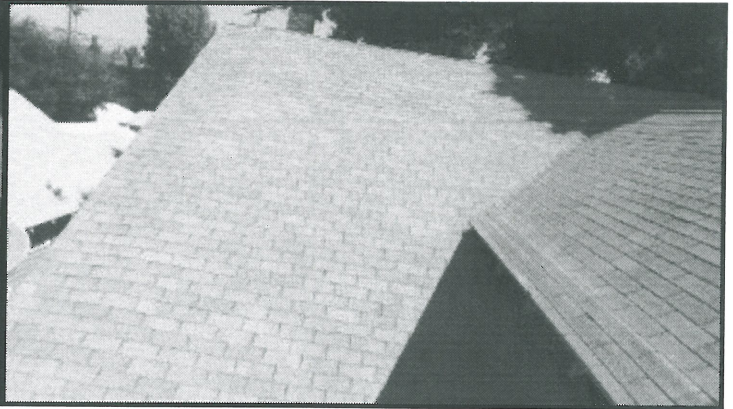
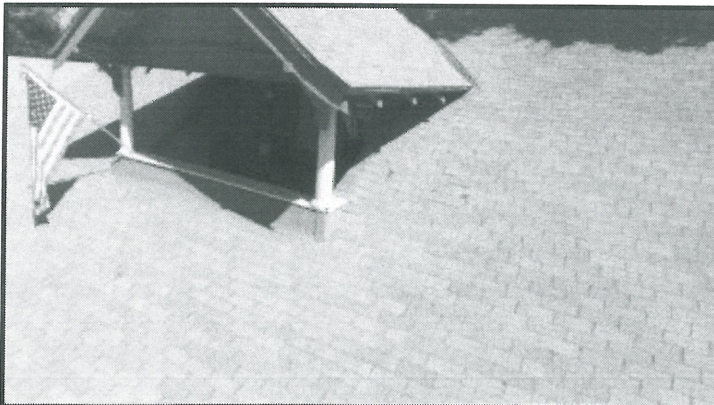
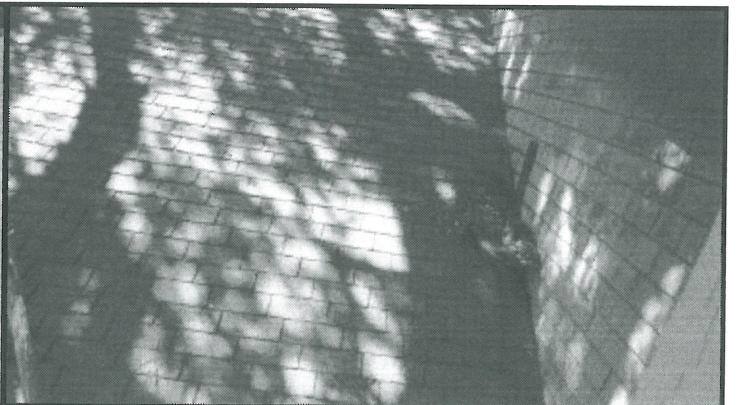
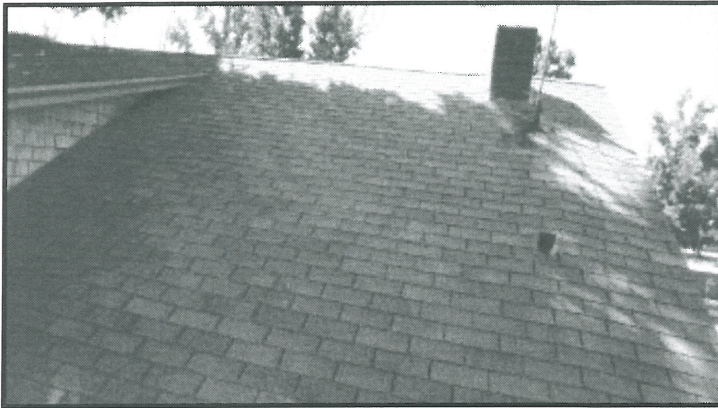
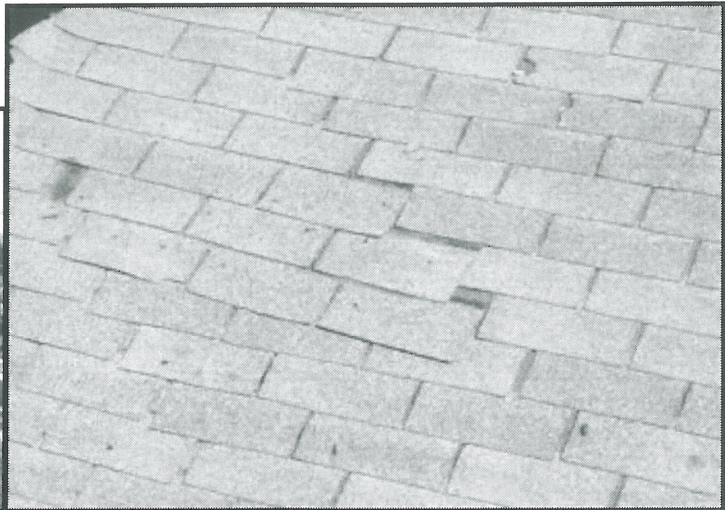
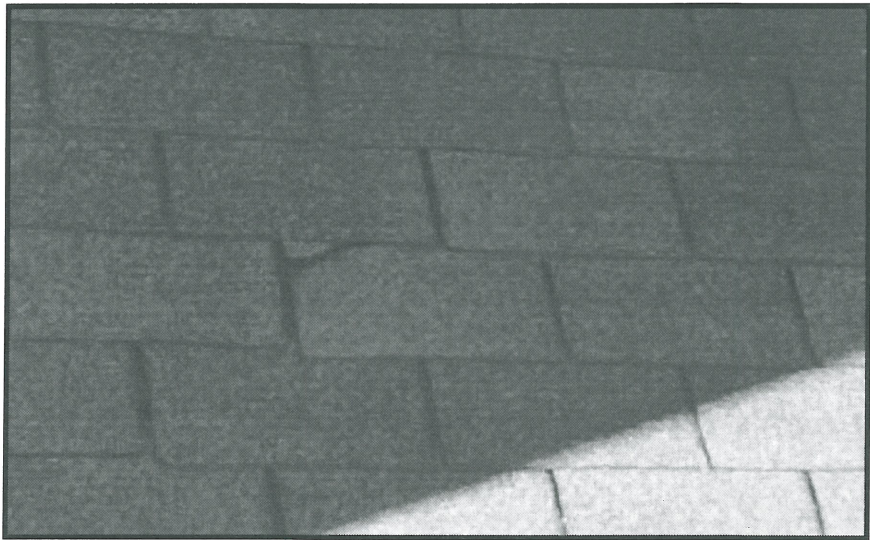
1. Roof Condition

| Page 16 Item: 1 | Roof Condition | <ul style="list-style-type: none"> • Sagging / buckling on roof decking. • Asphalt shingles at [location] on roof were damaged. Shingle tabs had chipped edges, possibly from mechanical or weather damage. Damage to shingles reduces the overall lifespan of the roof-covering system. Recommend replacing damaged shingles by a licensed, qualified roofing contractor • Clean roof areas: Significant amounts of organic debris evident. • Numerous trees and limbs were in contact or in very close proximity to roof at [location]. Physical damage to roof will occur by branch/limb movement making contact with roof system. Debris from trees can accumulate on shingles and promote algae growth, and fill the gutter system and prevent proper shedding of rainwater, resulting in diminished lifespan of the roof system. Recommend that a professional arborist trim the invasive branches that are in contact with and overhanging the roof. Homeowner should monitor condition for future problems and maintain adequate clearance as necessary. • Recommend further review for repair/replacement |

- Sagging / buckling on roof decking.
- Asphalt shingles at [location] on roof were damaged. Shingle tabs had chipped edges, possibly from mechanical or weather damage. Damage to shingles reduces the overall lifespan of the roof-covering system. Recommend replacing damaged shingles by a licensed, qualified roofing contractor

- Clean roof areas: Significant amounts of organic debris evident.
- Numerous trees and limbs were in contact or in very close proximity to roof at [location]. Physical damage to roof will occur by branch/limb movement making contact with roof system. Debris from trees can accumulate on shingles and promote algae growth, and fill the gutter system and prevent proper shedding of rainwater, resulting in diminished lifespan of the roof system. Recommend that a professional arborist trim the invasive branches that are in contact with and overhanging the roof. Homeowner should monitor condition for future problems and maintain adequate clearance as necessary.

| Year | Type of Work | Description of Work | Estimated Cost | |
|---|---|---|---|---|
| 2. | 6 | roofing | Re-roof entire residence and detached garage. Project will include all new pipe flashing, valley metal, and chimney metal. Apply Diamond Deck underlayment to roofs. Apply Class "A" CertainTeed Landmark Shingle to roofs. Seal and paint all pipes and vents. | \$33,470 |

- Recommend further review for repair/replacement

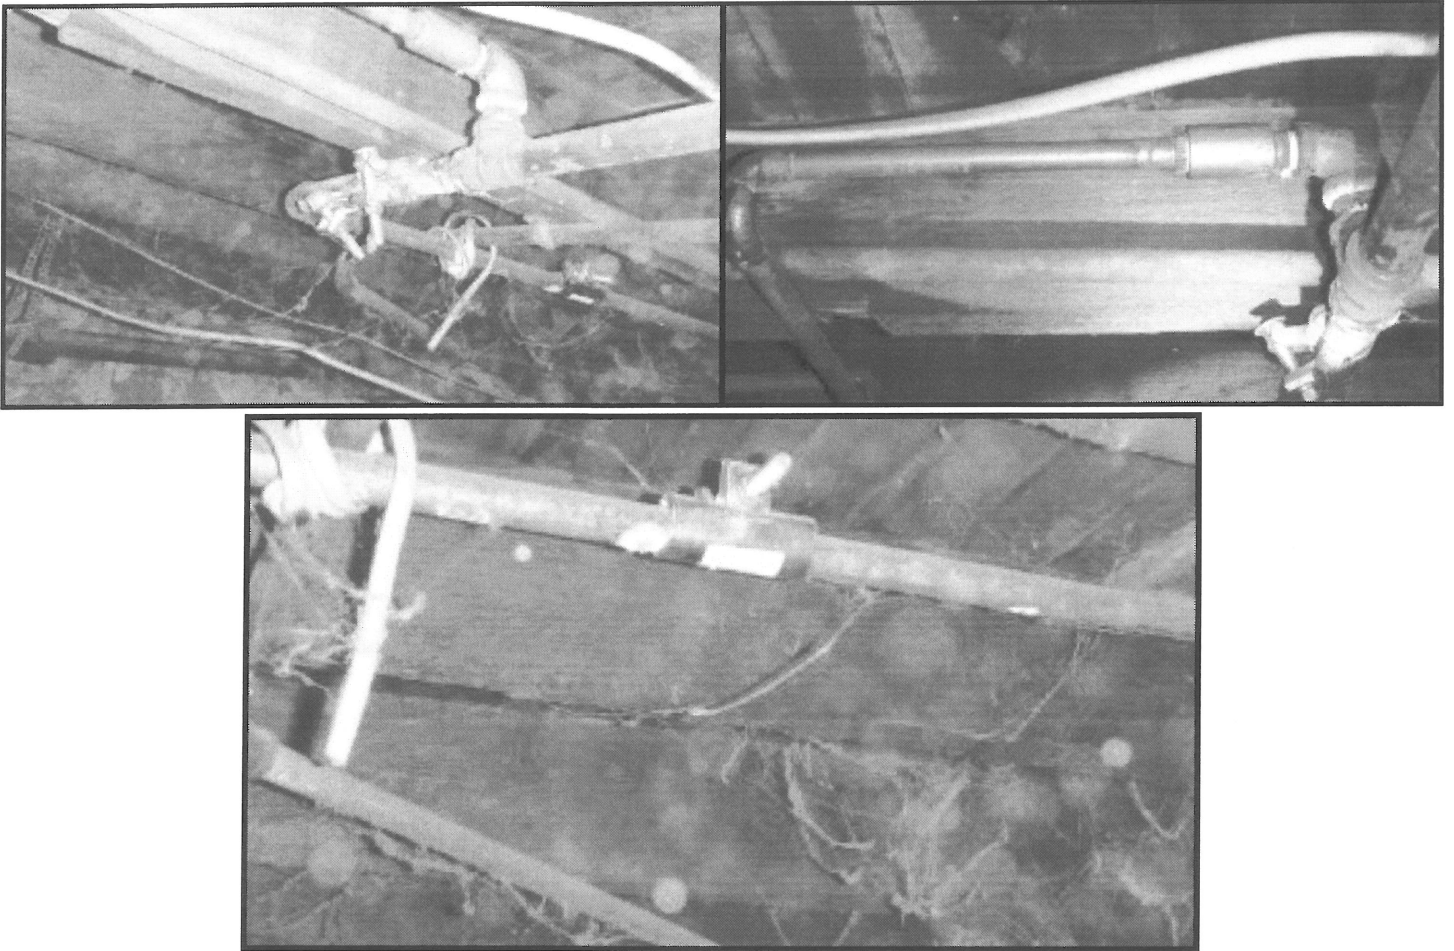
9. Foundation Plumbing

| Page 25 Item: 9 | Foundation Plumbing | <ul style="list-style-type: none"> • Galvanized and Copper plumbing pipes noted without proper connection. Copper and galvanized are considered dissimilar metals and over time accelerated corrosion will occur to the galvanized pipe even with a dielectric union present. Minerals in the water provide continuity for electrolysis to occur allowing galvanic reaction to deteriorate the galvanized pipes. Recommend replacement of galvanized pipe by a qualified plumber to prevent leaks due to accelerated corrosion of pipes. • Evidence of past water seepage. Corrosion present. Recommend repair by a licensed contractor • Temporary leak repairs were present. Recommend proper permanent repairs • Evidence of galvanized pipes deterioration and rust bleed through. Recommend a licensed plumber for repair options |

- Galvanized supply pipe noted.
- **DRAIN, WASTE, VENT**
- Cast iron waste and vent pipe noted.
- Acrylonitrile-Butadiene-Styrene "ABS" waste and vent pipes noted.
- Galvanized pipes present and has an average service life of 30 years. Pipes rust from the inside reducing the diameter and causing loss of pressure and rust in water. Recommend budgeting for replacement of galvanized piping in the near future.

- Galvanized and Copper plumbing pipes noted without proper connection. Copper and galvanized are considered dissimilar metals and over time accelerated corrosion will occur to the galvanized pipe even with a dielectric union present. Minerals in the water provide continuity for electrolysis to occur allowing galvanic reaction to deteriorate the galvanized pipes. Recommend replacement of galvanized pipe by a qualified plumber to prevent leaks due to accelerated corrosion of pipes.
- Evidence of past water seepage. Corrosion present. Recommend repair by a licensed contractor
- Temporary leak repairs were present. Recommend proper permanent repairs
- Evidence of galvanized pipes deterioration and rust bleed through. Recommend a licensed plumber for repair options

| Year | Type of Work | Description of Work | Estimated Cost | |
|---|---|---|---|---|
| 1. | 1 | Plumbing | Replace all drainage piping under home with correct size piping and slope. Add a clean out drain. Strup all hanging pipe. | \$5,000 |
