# *Structural Report*

*For*  
*251 Lincoln Ave.*  
*Pomona, CA 91767*

*November 06, 2019*

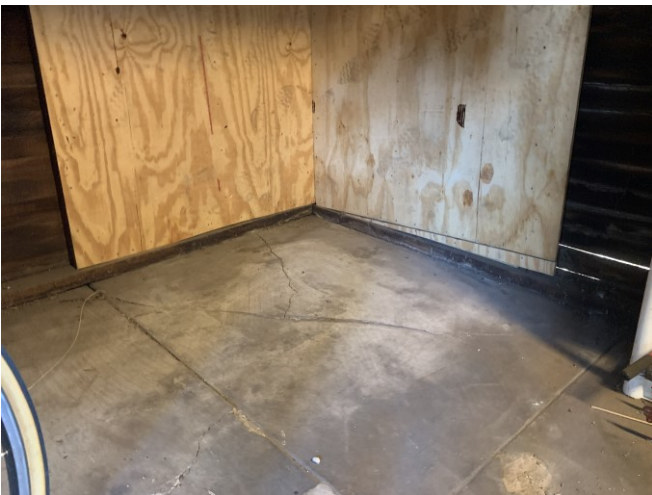
Picture #1

1. Picture 1 & 2 are showing the slanted floor at the north east corner of the garage.
2. Picture #2 is showing a live route is coming from underneath the slab.
3. Pictures 3 & 4 are showing a vertical displacement of 7" in 13' horizontal (5% Slope).
4. Picture #5 is showing a vertical displacement of the roof framing of the garage.

It was clear that the oak tree route in the back of the garage is still growing under the garage slab and it is actively pushing up the garage slab to the extent that the garage roof is starting to move up (see crack on picture #5).

An immediate action is needed to stop the tree route from damaging the garage. The tree route has to be removed entirely before the damage continues to destroy the garage framing as well as it damaged the corner of the slab.
