Historic Preservation Application

WINDOW ASSESSMENT FORM

Description of Project – Front Living Room Window (#1)

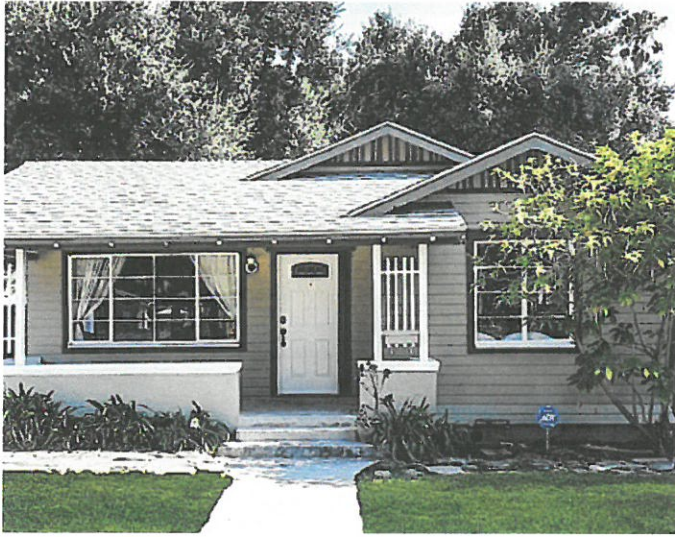
Front of House Facing Columbia Ave.

Before

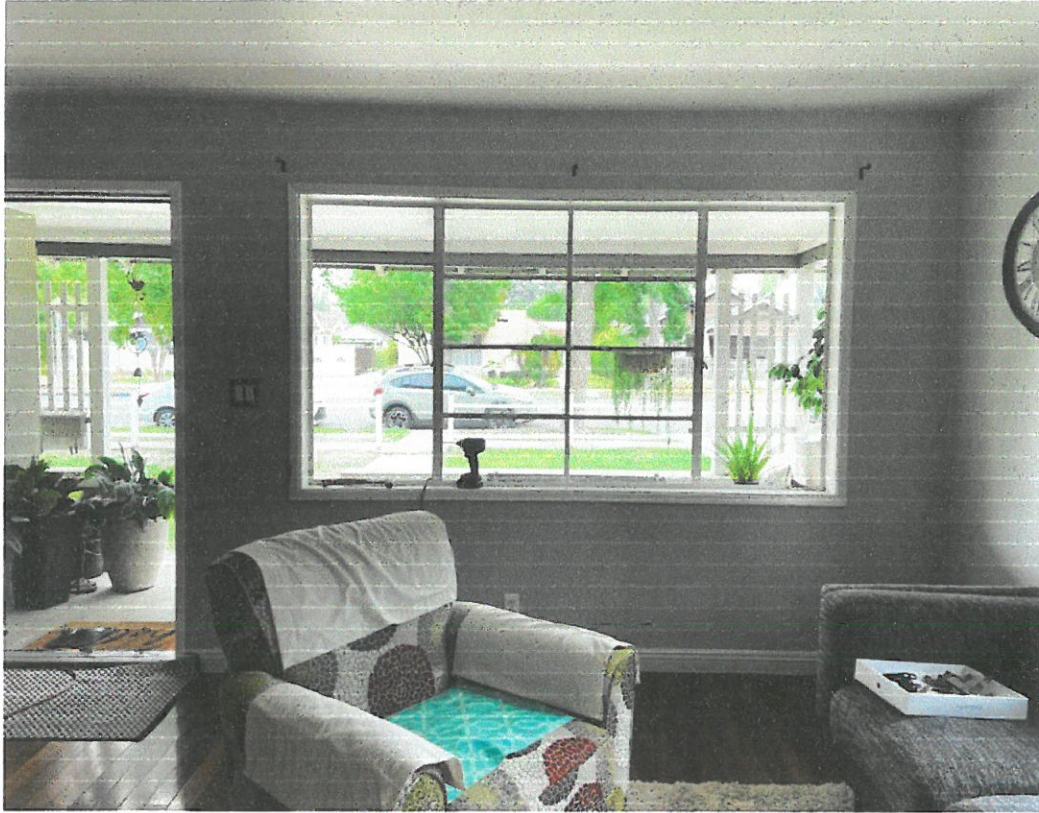
Front facing Window (columbia Ave.) 1

Window Description: Single pane,
casement window - one on each side
of the main window, horizontal pane
design, wood stool, apron & sill.
Some of the muntins have rusted
and was painted over. Surface
of grilles/muntins was bumpy, cracking,
and uneven in appearance.

- I wanted to have functional windows that could properly be opened and closed from the inside of the home. The window cranks on each side of the main window were damaged and not working properly. The windows could be unlocked from the inside of the home; however, the cranks were inoperable, not allowing the windows to be opened unless pushed out. To close the window, one would have to go outside of the home, push the window closed, then locked on the inside for safety/security.

Before

- My intent was to keep the window grid style the same so as not to change the look of the windows. I went so far as to get casement windows (with horizontal muntins) with crank handles.
- The size of the window remained the same. The windowsill was not changed, removed, or replaced. Windows now have screens to allow for ventilation without insects entering into the home.

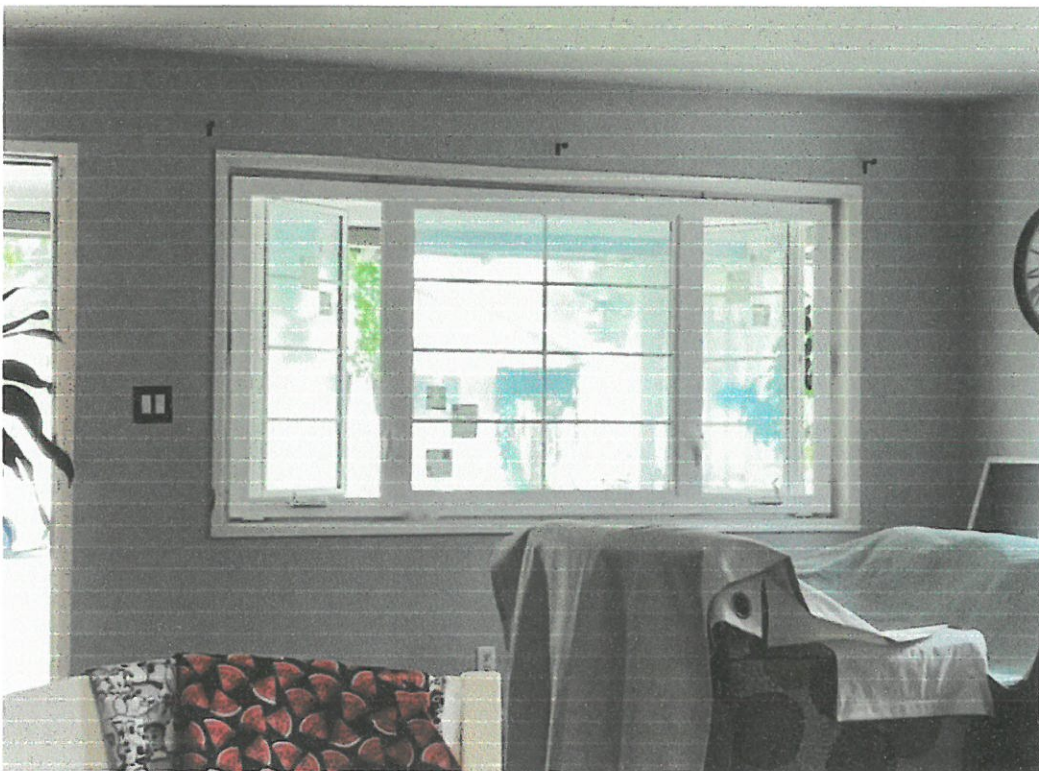
After

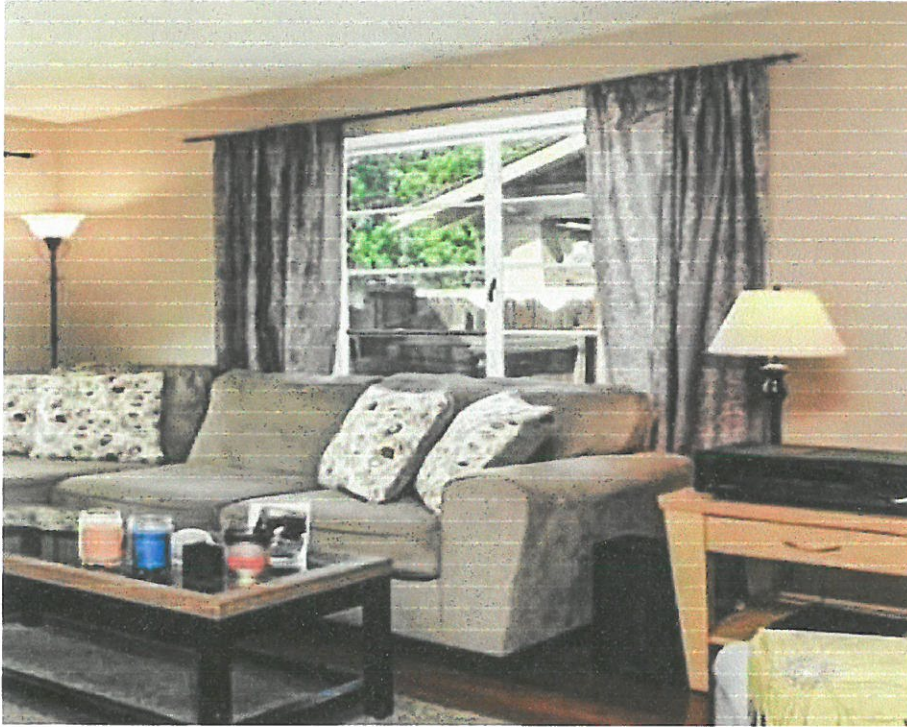
2

Window Description: Single paned, one casement window. Horizontal pane. Wood stool, apron and sill. Grilles were rusted and painted over leaving surface bumpy and uneven.

- I wanted to have functional windows that could be properly opened and closed from the inside of the home. The old window crank did not work. The window would stick and was hard to open. To open the window, one would need to put pressure on the casement in order for it to open. The window could not be closed from the inside of the house unless it was pushed from the outside.

- I was also concerned that the window frame would crack or break if pressure was placed on the frame of the window when attempting to open it due to the existing rust and cracks.

Before

- My intent of removing and replacing the window was to keep the look the same, like for like, with the difference being replacing the single paned window with a double paned window to keep costs down and noise to a minimum.
- The size of the window remained the same. The windowsill was not changed, removed, or replaced.
- Window screens were installed for ventilation and to keep insects (especially the flies) out while the windows were open. There were no window screens on the windows upon purchase of the home.

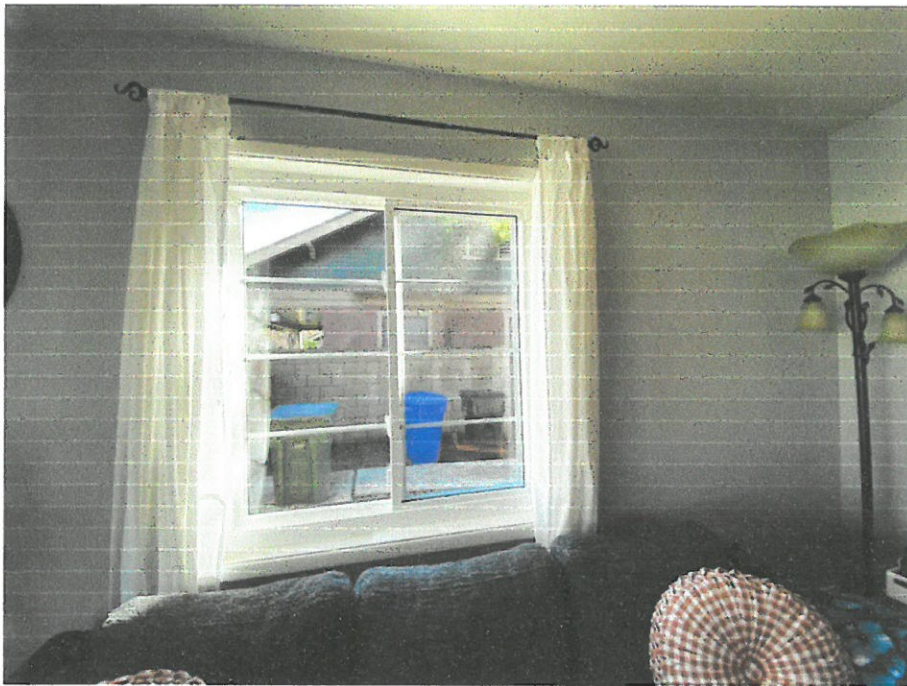
After

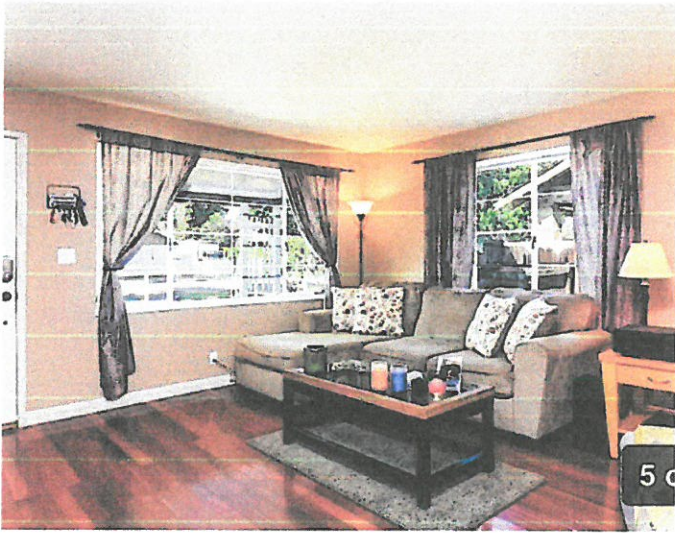
1 1/2

Before

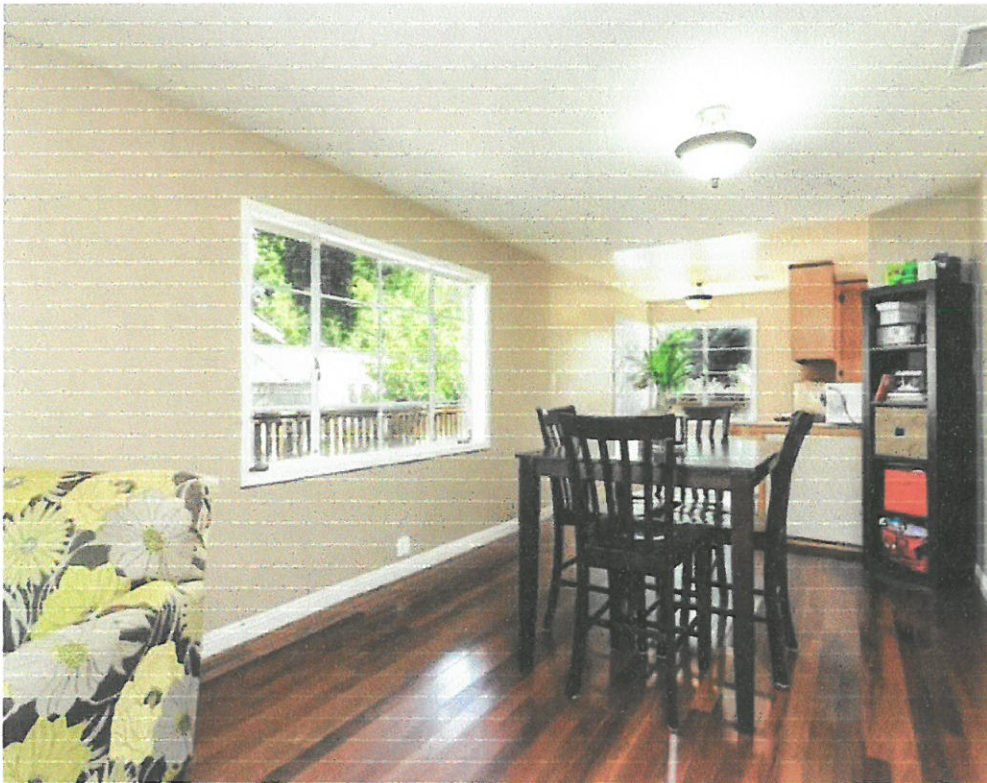
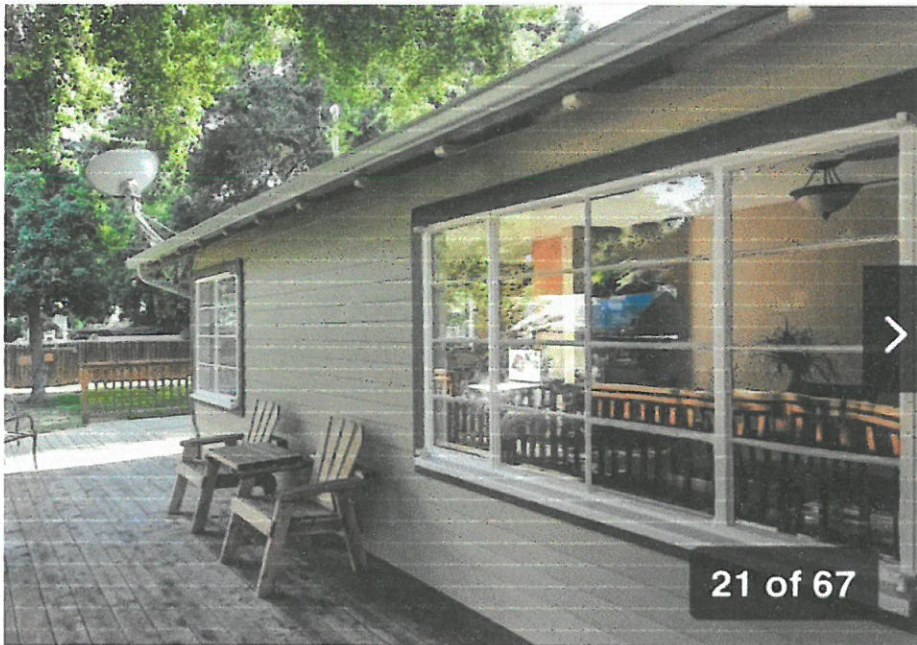
3

- I wanted to replace the single paned windows and non-operable casement, crank windows with energy efficient double-paned glass to keep costs down and to have functional, working windows for adequate ventilation during the hot summer months.

Before

- Remove existing dining room window and replace with custom fitting French doors within the allotted window space.
- Due to the length of the window, to prevent excess cutting into the existing wall, side lights were installed.
