# CERTIFICATE OF APPROPRIATENESS APPLICATION

Property Address: 406 E Alvarado St Zip Code: 91767  
Assessor's Parcel No(s): 8337-004-023  
Cross Streets: E Alvarado St and N Towne Ave

Replace 20 windows, same size, same type (wood frame, single pane).

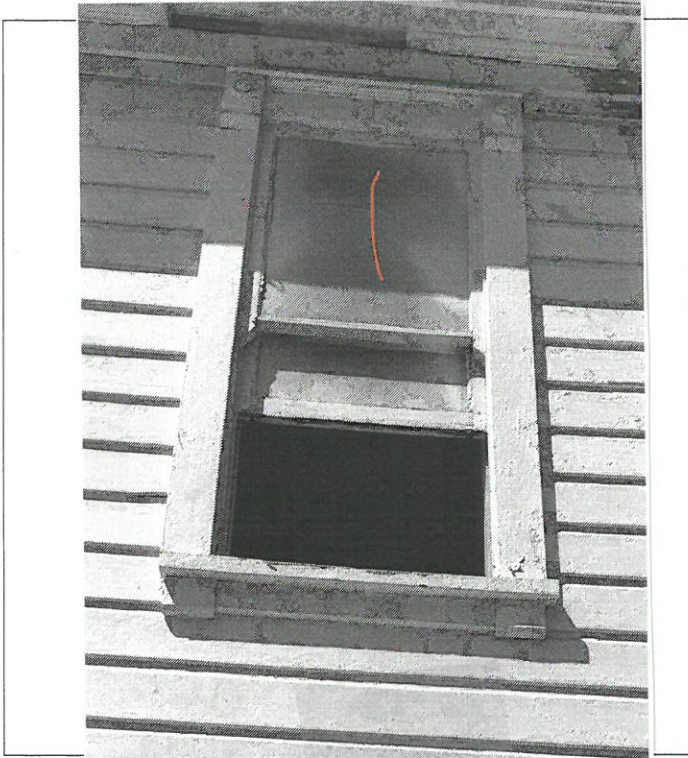
Bedroom 3

28<sup>3</sup>/<sub>8</sub>" x 68<sup>1</sup>/<sub>2</sub>"  
Wood Frame, Single Pane

☐ Excellent ☐ Good ☐ Fair ☒ Poor ☐ Deteriorated to point of being dangerous

Major damage to wood frame, unable to repair.

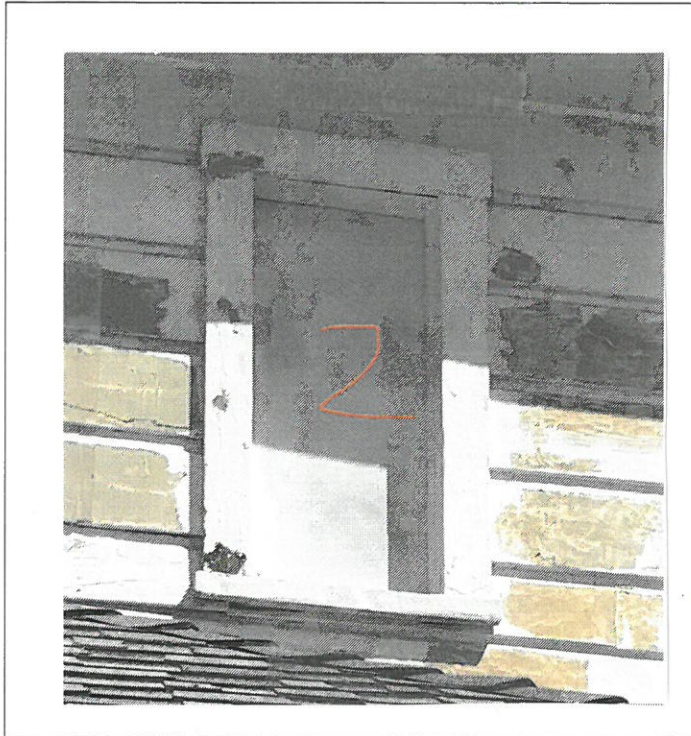
UPSTAIRS  
BATHROOM 3

15 3/8" x 35 3/8"  
Wood Frame, Single Pane

☐ Excellent ☐ Good ☐ Fair ☒ Poor ☐ Deteriorated to point of being dangerous

Major damage to wood frame, unable to repair.

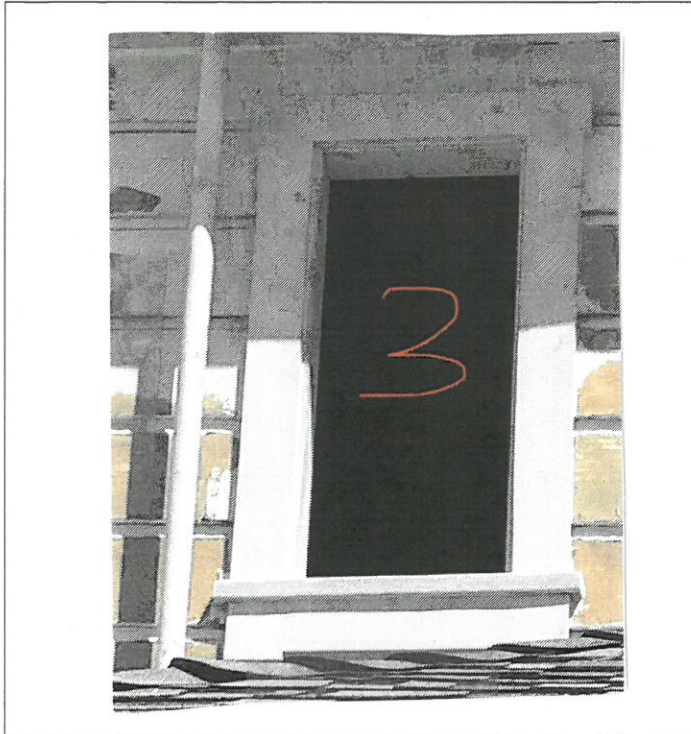
Window Location: Bedroom 3

Window Description: 15 3/8" x 36 3/8"  
Wood Frame, Single Pane

☐ Excellent ☐ Good ☐ Fair ☒ Poor ☐ Deteriorated to point of being dangerous

Major damage to wood frame, unable to repair.

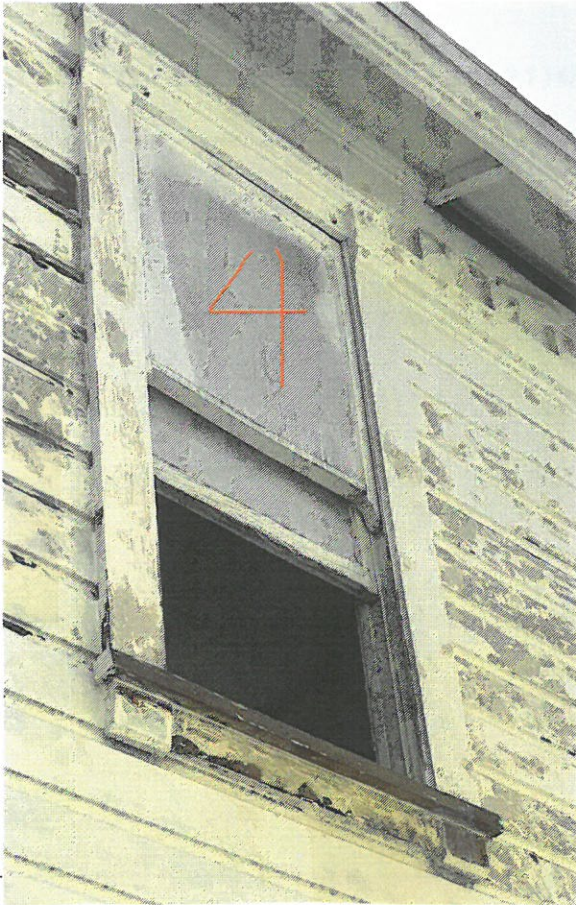
upstairs  
BATHROOM 3

28 3/8" x 69"  
Wood Frame, Single Pane

☐ Excellent ☐ Good ☐ Fair ☒ Poor ☐ Deteriorated to point of being dangerous

Major damage to wood frame, unable to repair.

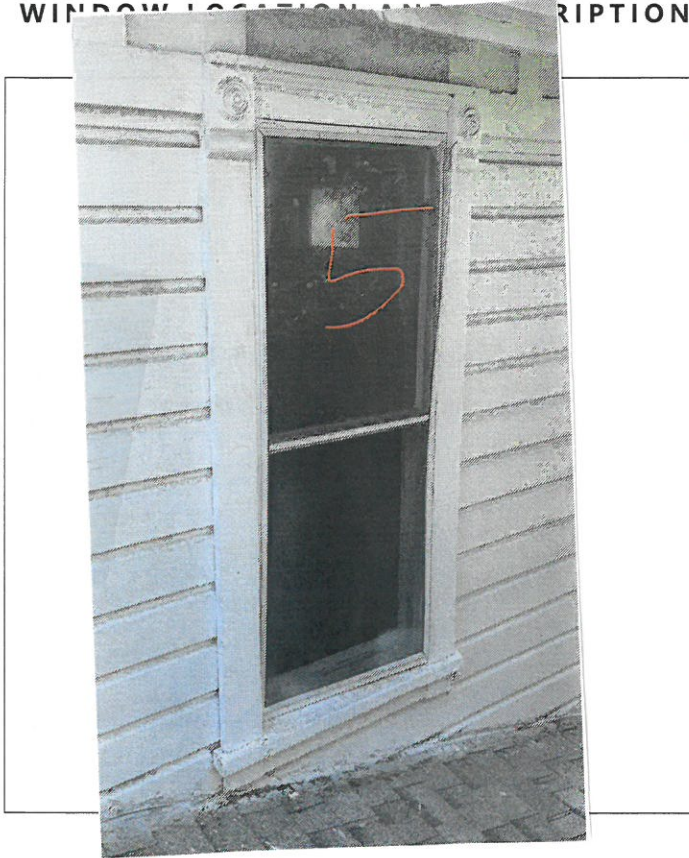
Window Location: Bedroom 2

Window Description: 28" x 68 3/8"  
Wood Frame, Single Pane

☐ Excellent ☐ Good ☐ Fair ☒ Poor ☐ Deteriorated to point of being dangerous

Major damage to wood frame, unable to repair.

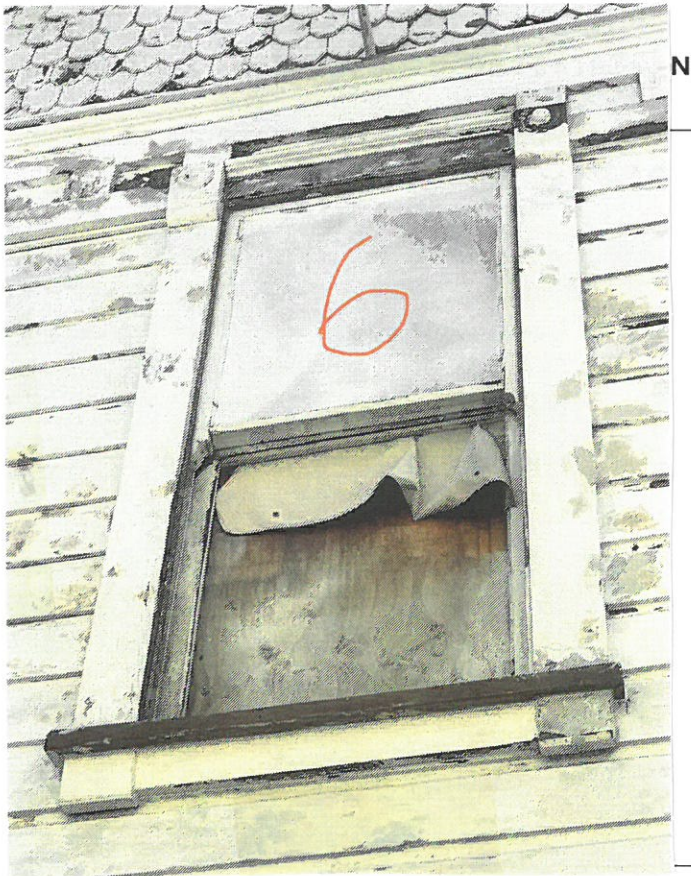
Bedroom 2

28" x 68 3/8"  
Wood Frame, Single Pane

☐ Excellent ☐ Good ☐ Fair ☒ Poor ☐ Deteriorated to point of being dangerous

Major damage to wood frame, unable to repair.

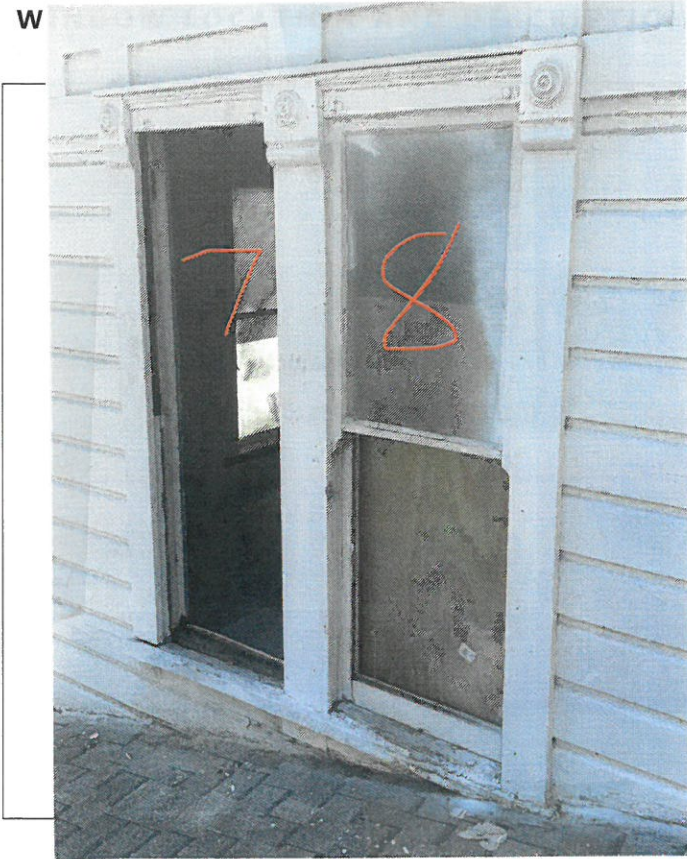
Window Location: Bedroom 1

Window Description: 24" x 69" ea.  
Wood Frame, Single Pane

☐ Excellent ☐ Good ☐ Fair ☒ Poor ☐ Deteriorated to point of being dangerous

Major damage to wood frame, unable to repair.

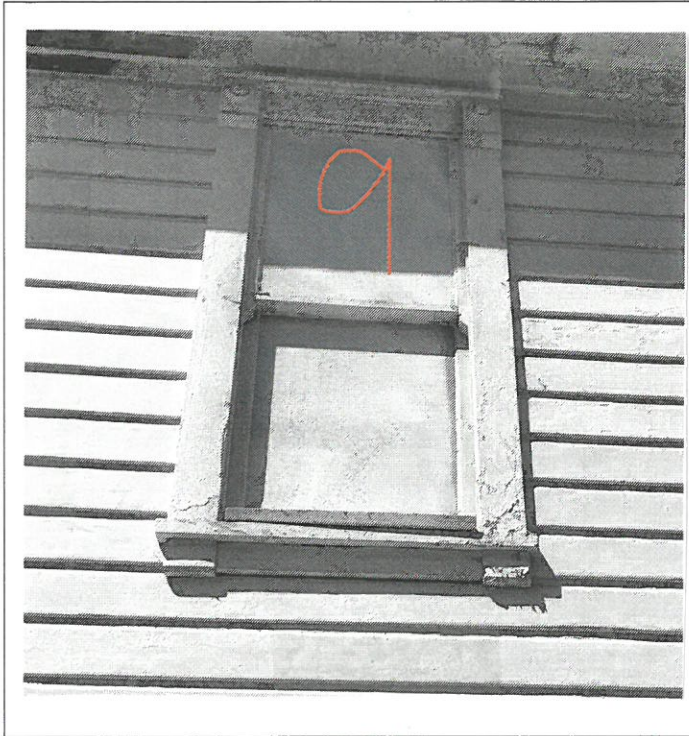
Bedroom 1

28" x 69"

☐ Excellent ☐ Good ☐ Fair ☒ Poor ☐ Deteriorated to point of being dangerous

Major damage to wood frame, unable to repair.

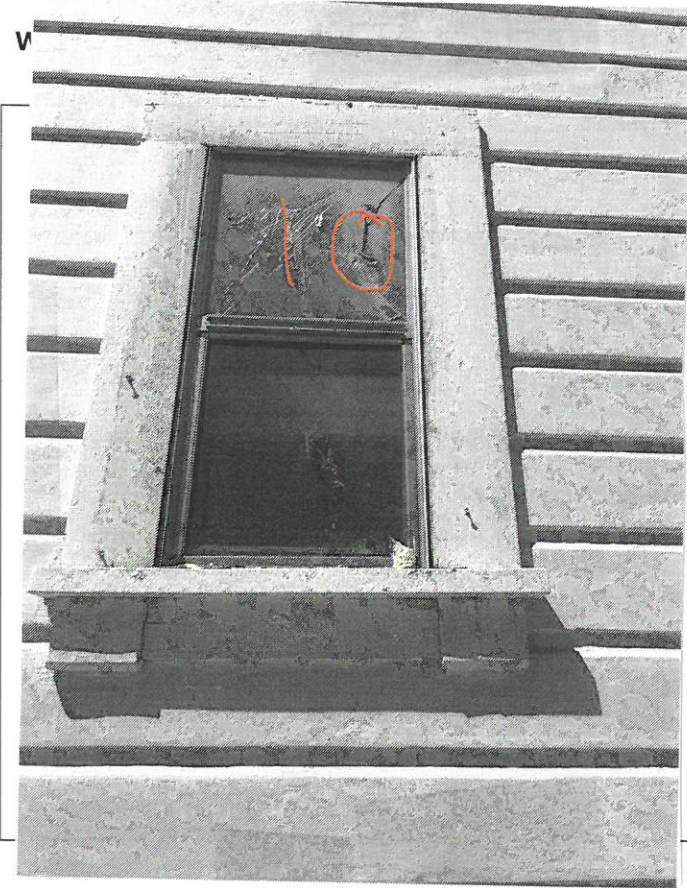
Stairway

15 3/4" x 34"

☐ Excellent ☐ Good ☐ Fair ☒ Poor ☐ Deteriorated to point of being dangerous

Major damage to wood frame, unable to repair.

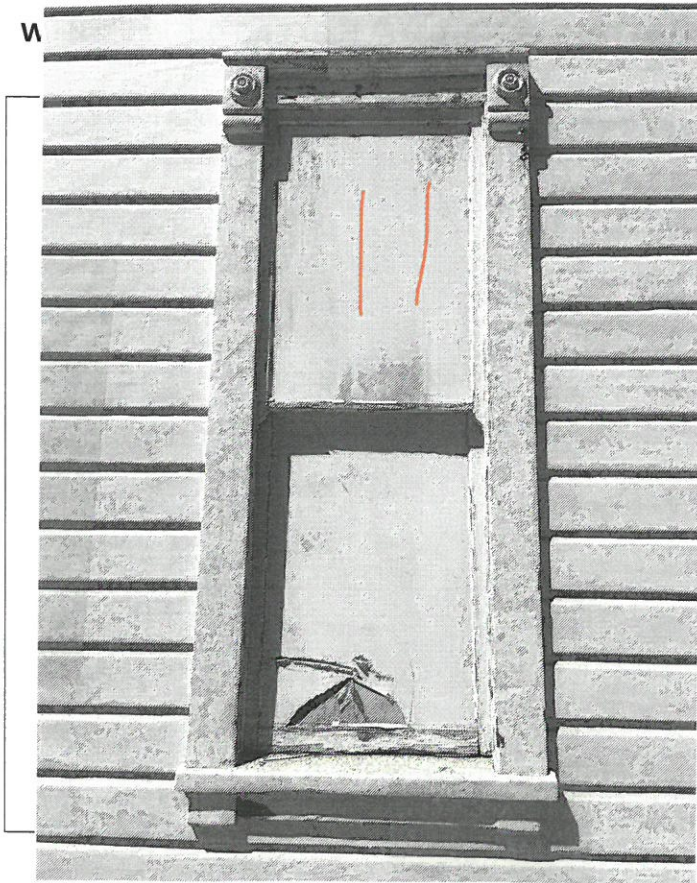
Window Location: Living Room

Window Description: 28" x 75 3/4"  
Wood Frame, Single Pane

☐ Excellent ☐ Good ☐ Fair ☒ Poor ☐ Deteriorated to point of being dangerous

Major damage to wood frame, unable to repair.

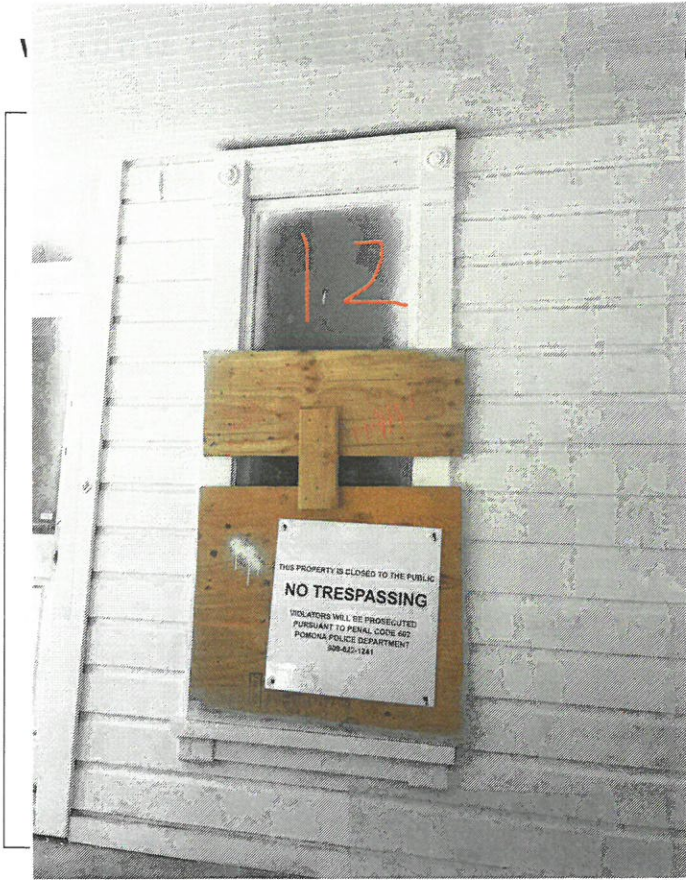
Window Location: LIVING ROOM

Window Description: 28" x 75 3/4"  
Wood Frame, Single Pane

☐ Excellent ☐ Good ☐ Fair ☒ Poor ☐ Deteriorated to point of being dangerous

Major damage to wood frame, unable to repair.

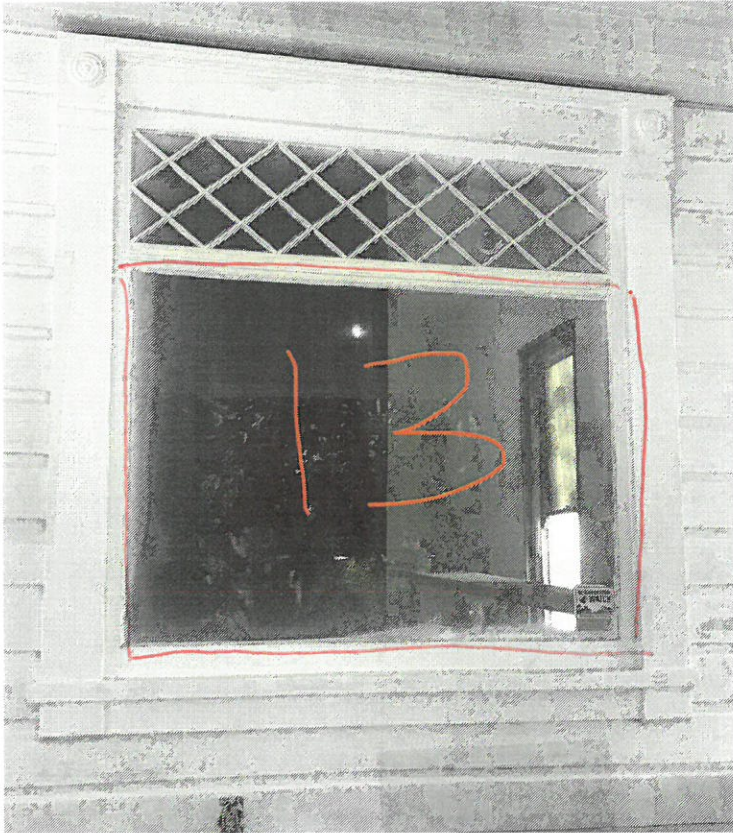
Window Location: LIVING ROOM

Window Description: 40" x 59"  
Wood Frame, Single Pane

☐ Excellent ☐ Good ☐ Fair ☒ Poor ☐ Deteriorated to point of being dangerous

Major damage to wood frame, unable to repair.

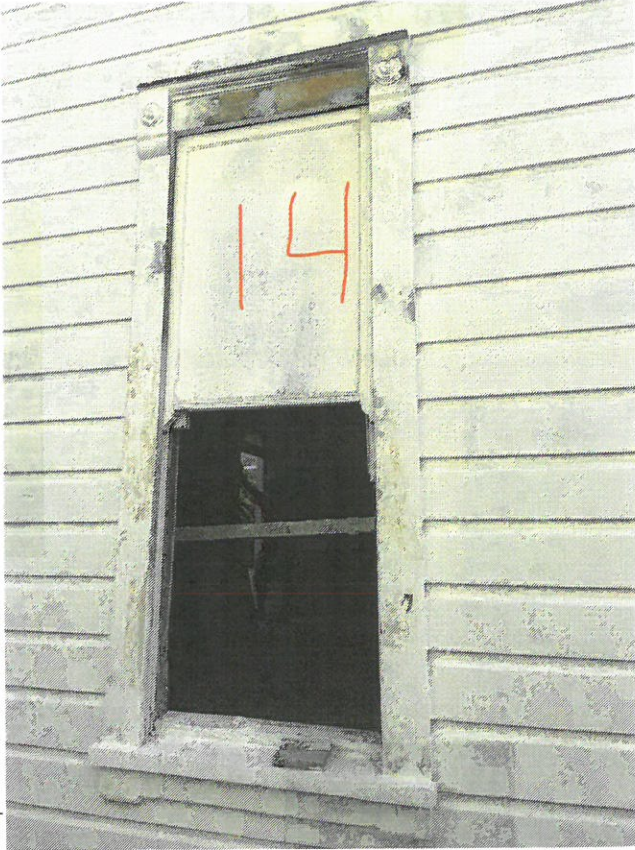
LIVING ROOM

28 1/2" x 76 1/2"

☒ Poor

Major damage to wood frame, unable to repair.

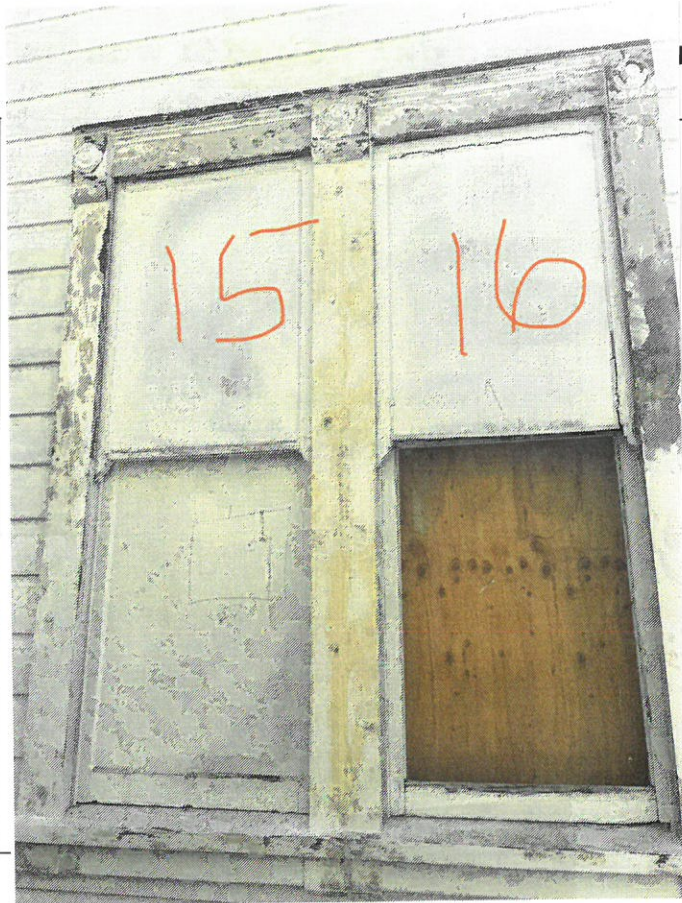
Window Location: Dining Room

Window Description: 28" x 76 1/2" ea.  
Wood Frame, Single Pane

☐ Excellent ☐ Good ☐ Fair ☒ Poor ☐ Deteriorated to point of being dangerous

Major damage to wood frame, unable to repair.

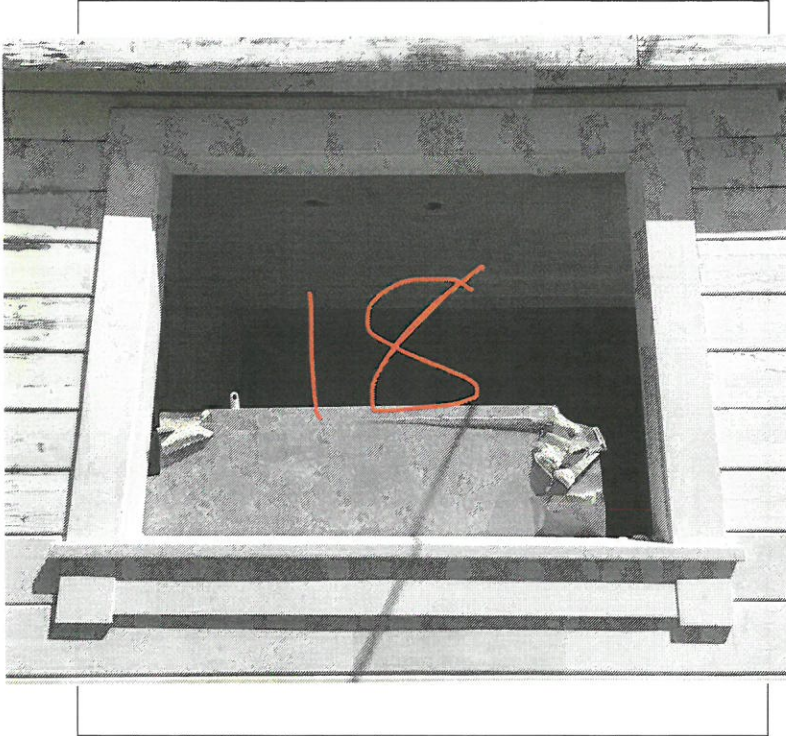
Window Location: Kitchen

Window Description: 56" x 43 1/2"  
Wood Frame, Single Pane

☐ Excellent ☐ Good ☐ Fair ☒ Poor ☐ Deteriorated to point of being dangerous

Major damage to wood frame, unable to repair.

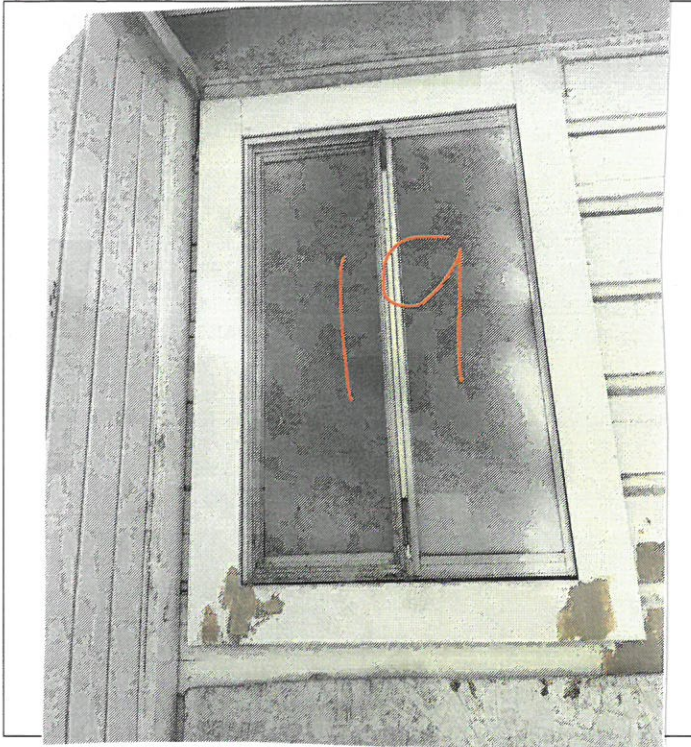
downstairs  
Bathroom

21" X 33"  
Wood Frame, Single Pane

☐ Excellent ☐ Good ☐ Fair ☒ Poor ☐ Deteriorated to point of being dangerous

Major damage to wood frame, unable to repair.

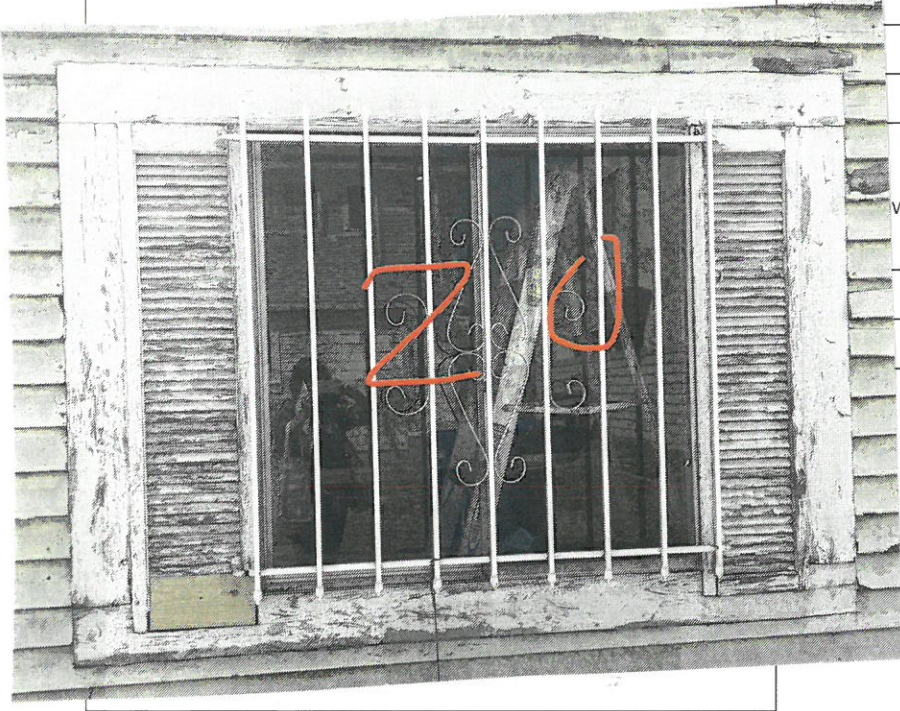
Garage

3'10" X 3'10"

☐ Excellent ☐ Good ☐ Fair ☒ Poor ☐ Deteriorated to point of being dangerous

Major damage to wood frame, unable to repair.
