To: Farook Zia
From: Javier Cabral / Consulting Arborist
Date: October 20, 2021
Subject: 1137 & 1149 Philips Ranch Rd.

1137 & 1149 W. Philips Ave Pomona, CA 91766

Table of contents

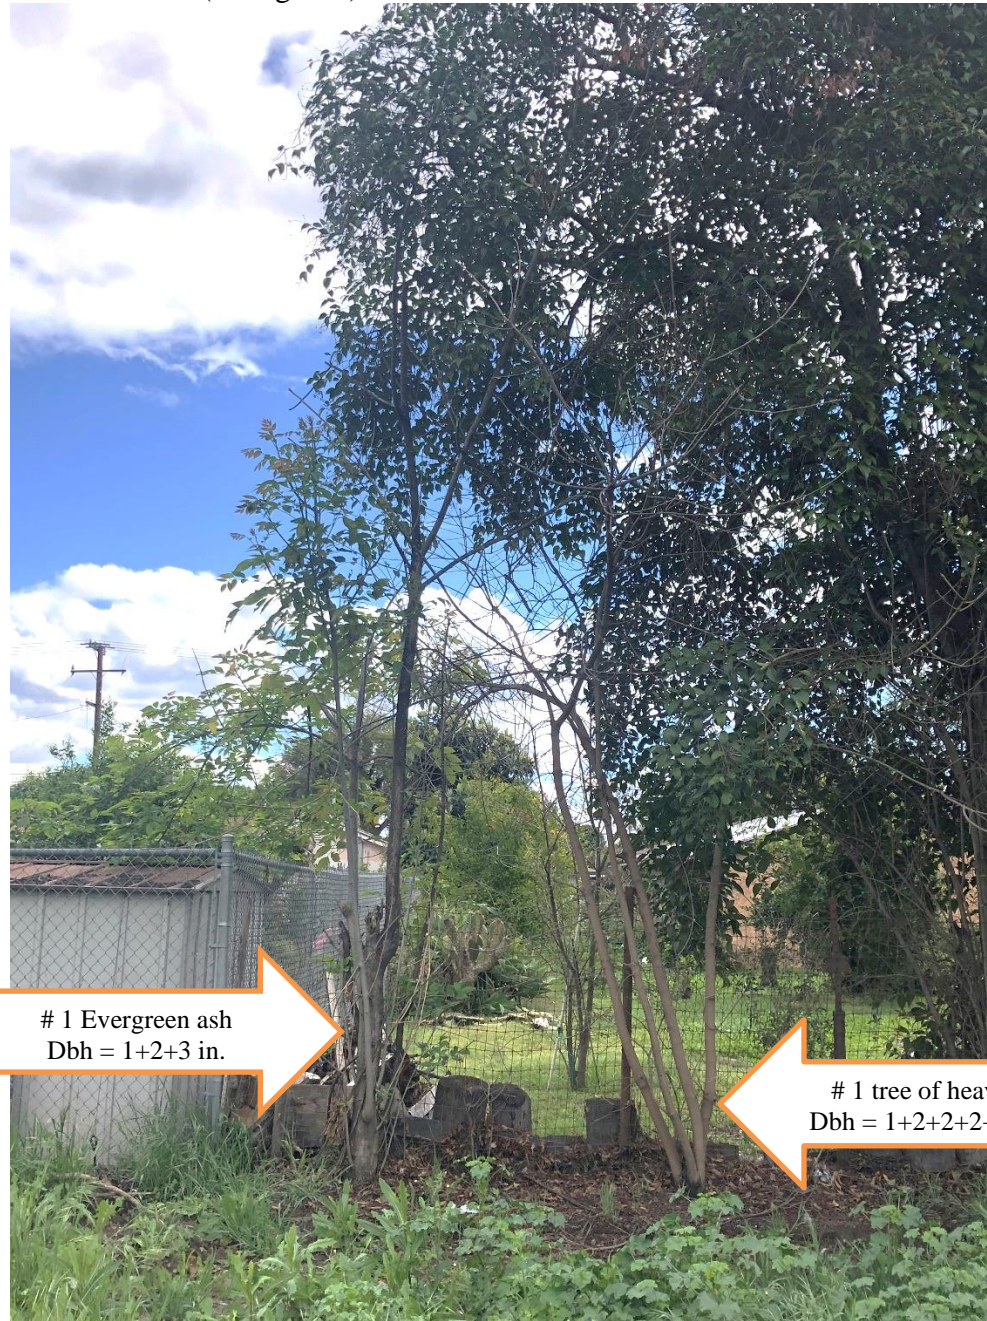
Trees # 1 & 2 (facing east)

1 Evergreen ash
Dbh = 1+2+3 in.

1 tree of heaven
Dbh = 1+2+2+2+2 in.

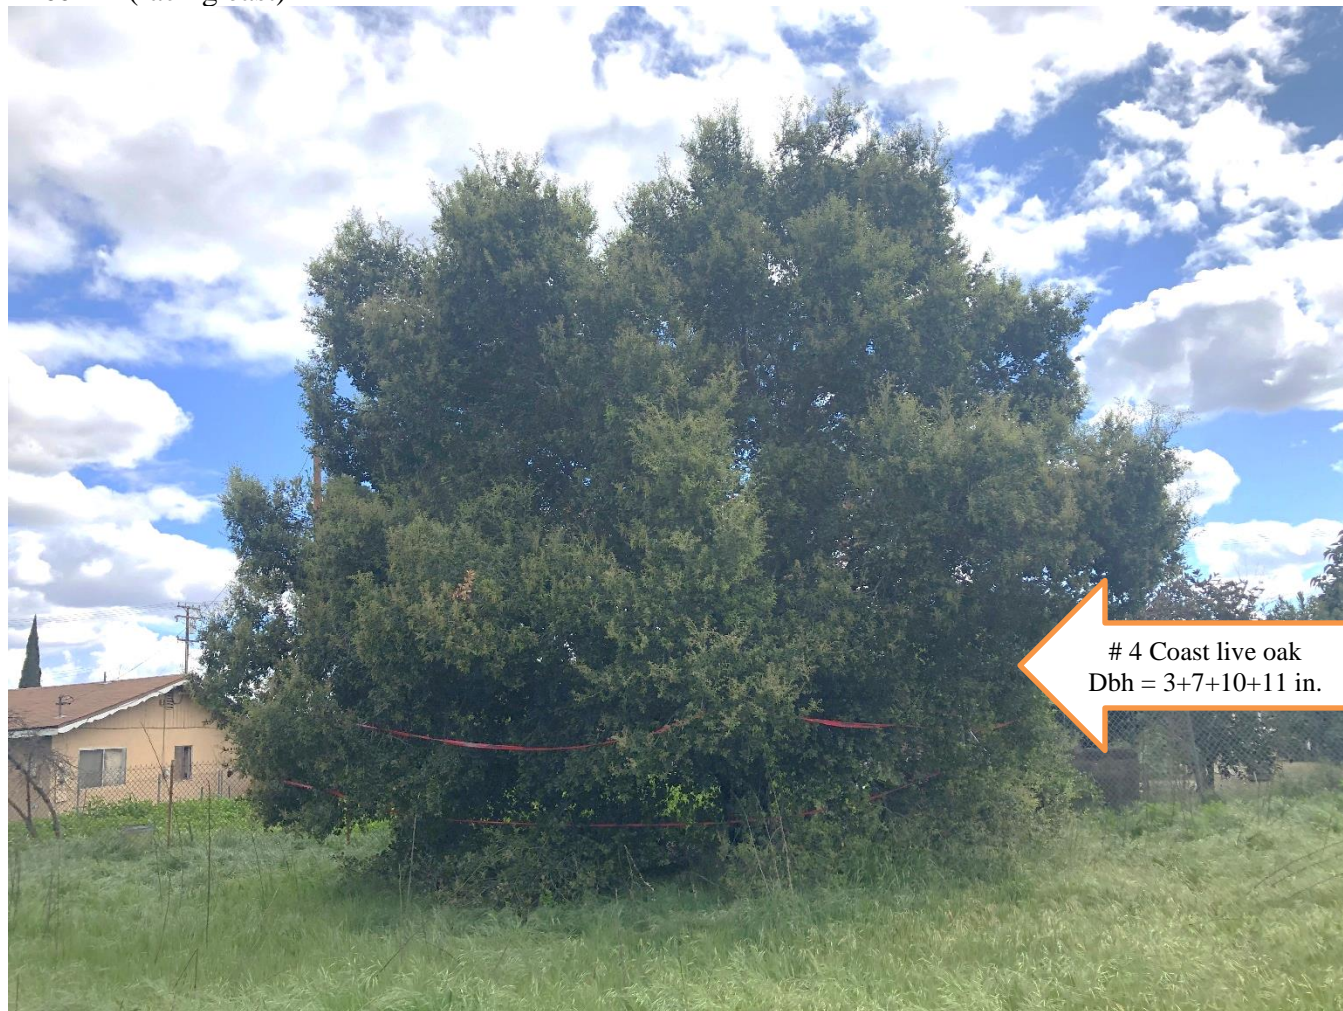
Tree # 4 (facing east)

This memorandum is to address the translatability of one *Coast live oak tree # 4 on the tree inventory. This Oak tree sits directly on the footprint of the proposed rear unit and cannot be saved.*

- 2) A multi-trunk tree such as Tree # 4 Oak is also not compatible with the dimensions of the landscape areas because as a multi trunk tree the base is very wide at the bottom and would severely crowd the usable area for to be used as a common garden.

- 4) I would be highly recommend a new container grown tree be planted in a size and location on the site where it can grow and thrive for many years instead of risking disease on a tree that will be challenged to survive all of the risks and challenges of transplanting.

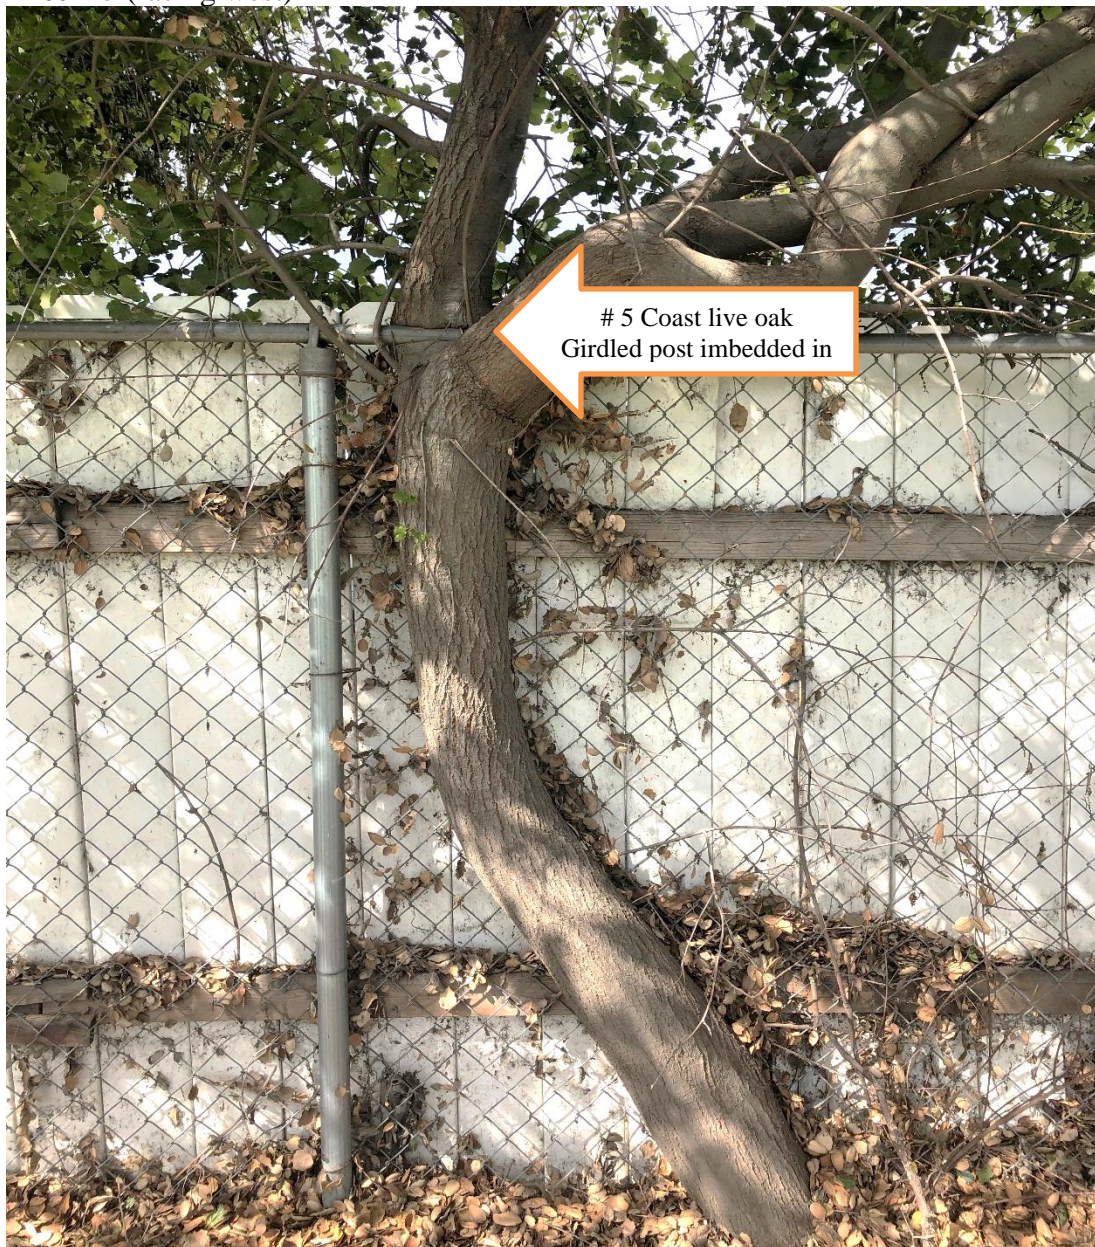
Tree # 5 (facing west)

5 Coast live oak
Dbh = 6 in.

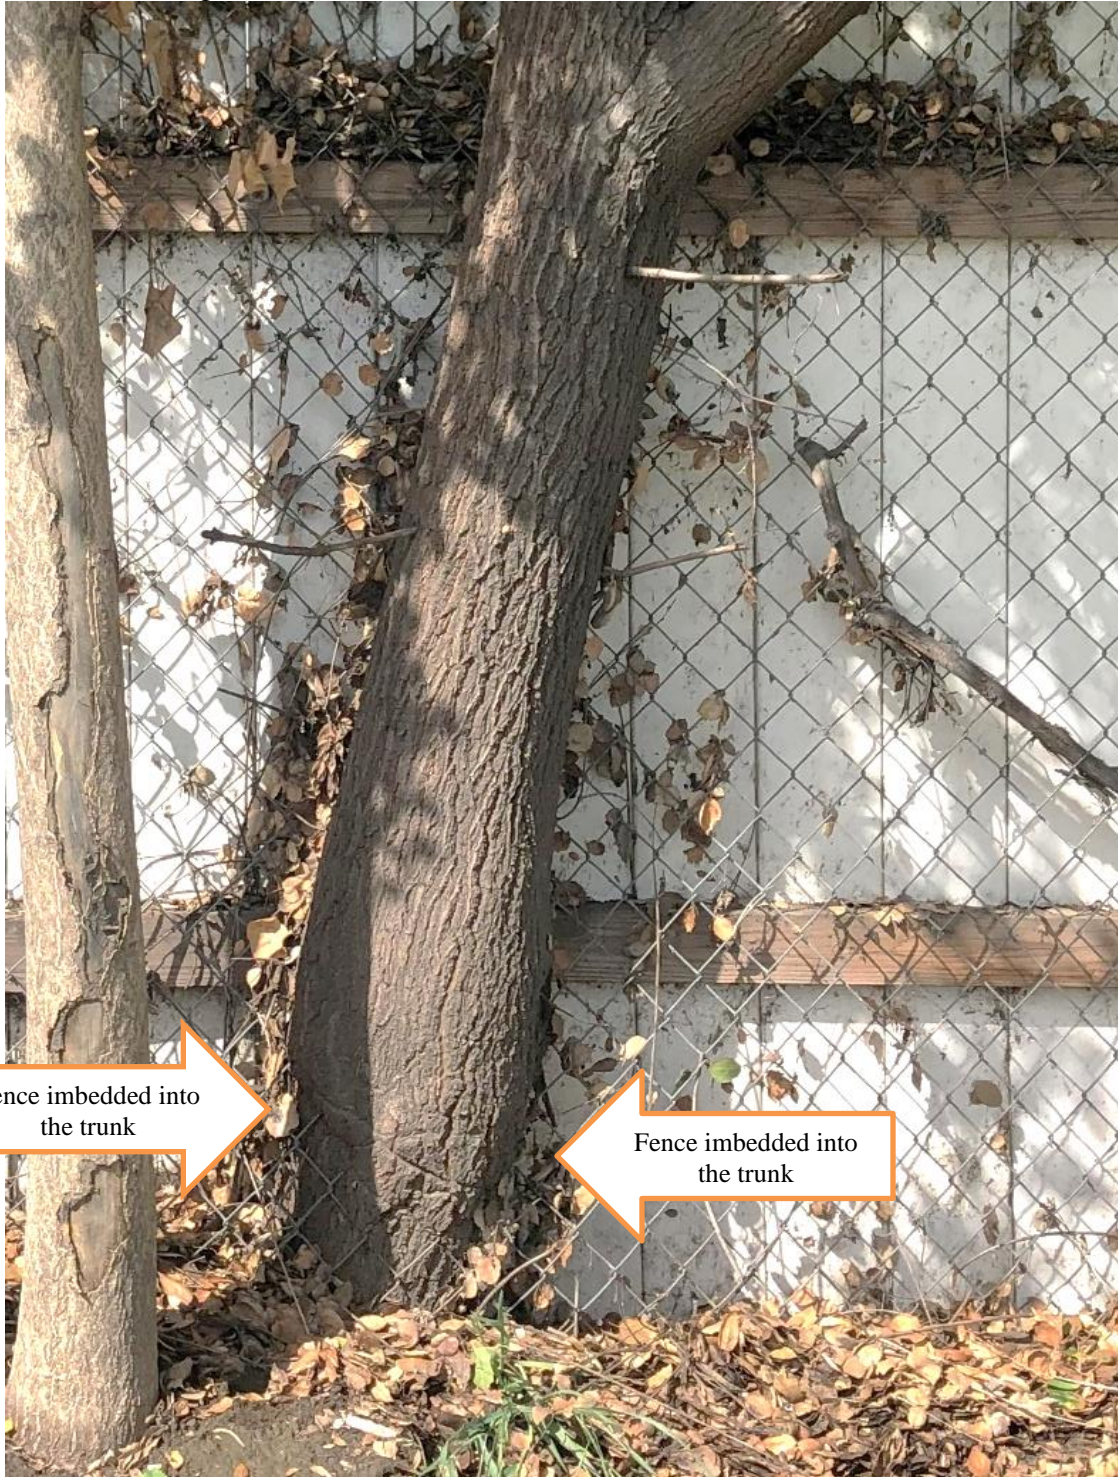
Tree # 6 (facing west)

6 Coast live oak
Dbh = 10 in.

Fence imbedded into
the trunk

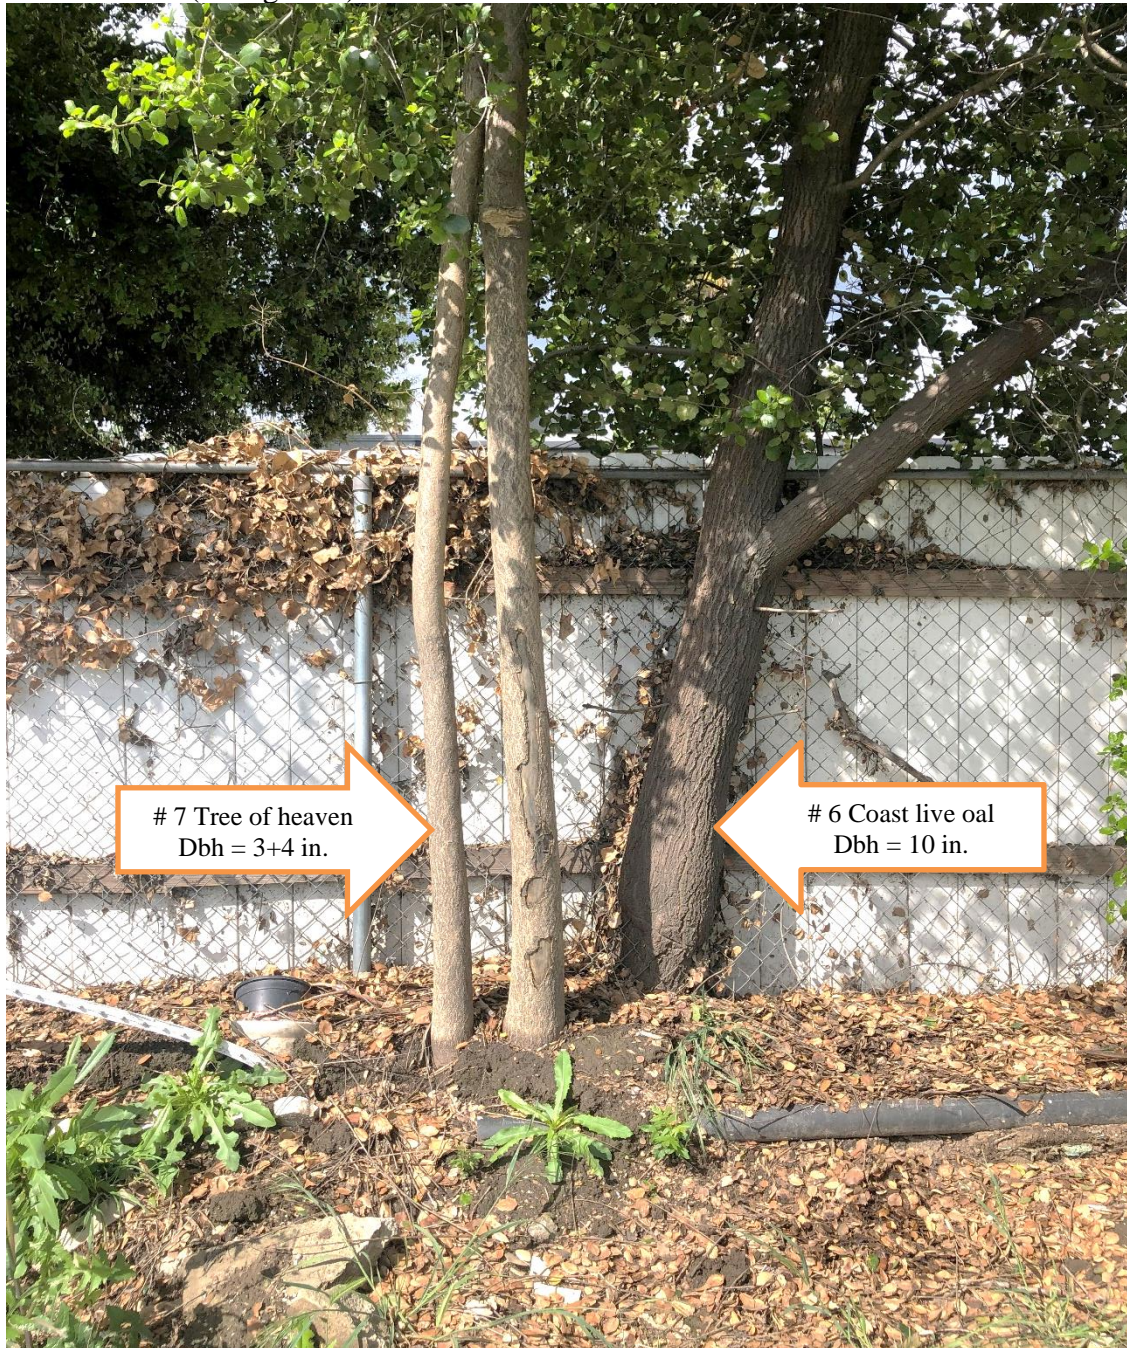
Trees # 6 & 7 (facing west)

Fence imbedded into
the trunk

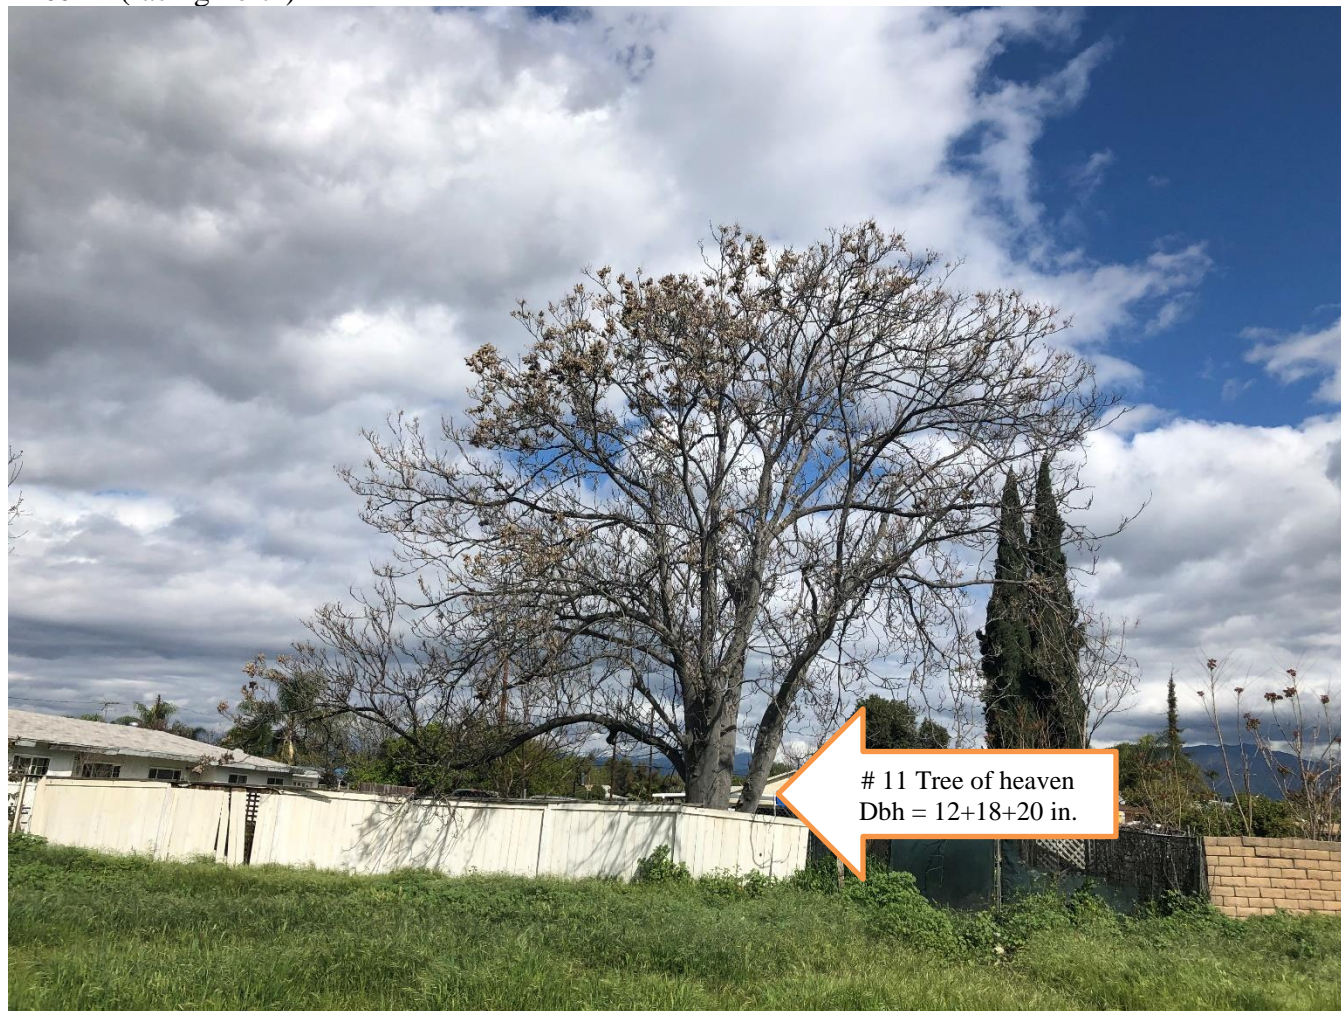
Tree 11 (facing north)

11 Tree of heaven
Dbh = 12+18+20 in.
