State of California - The Resources Agency  
DEPARTMENT OF PARKS AND RECREATION

PRIMARY RECORD

\*Resource Name or #: (Assigned by Recorder) 1515 GANESHA

c. Address 1515 GANESHA City: Riverside Zip \_\_\_\_\_

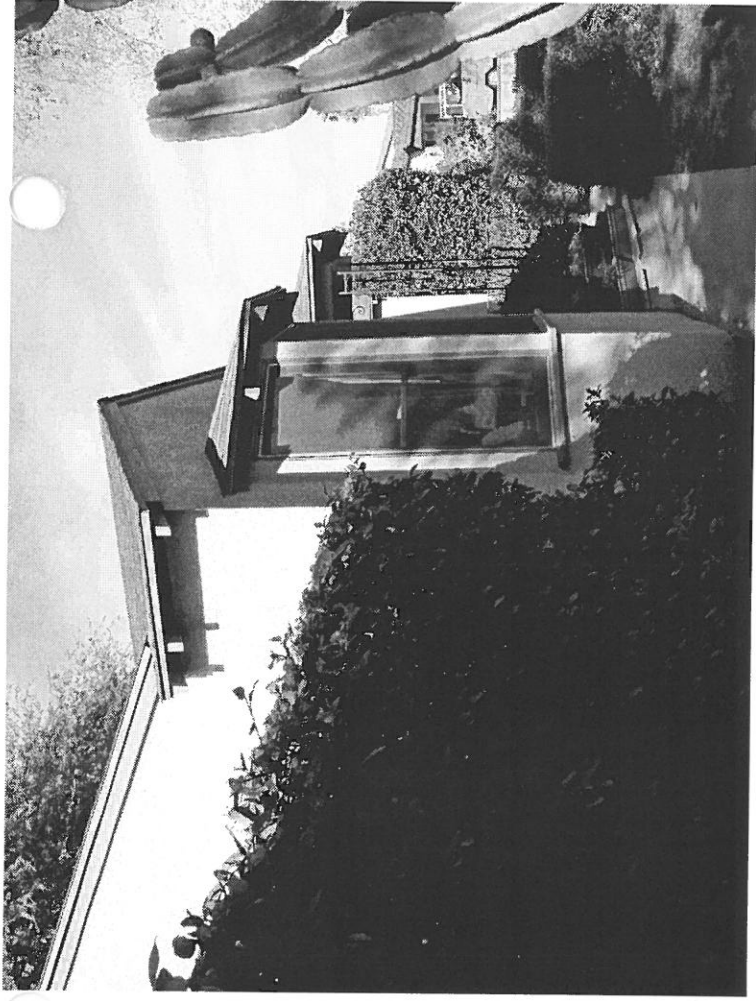
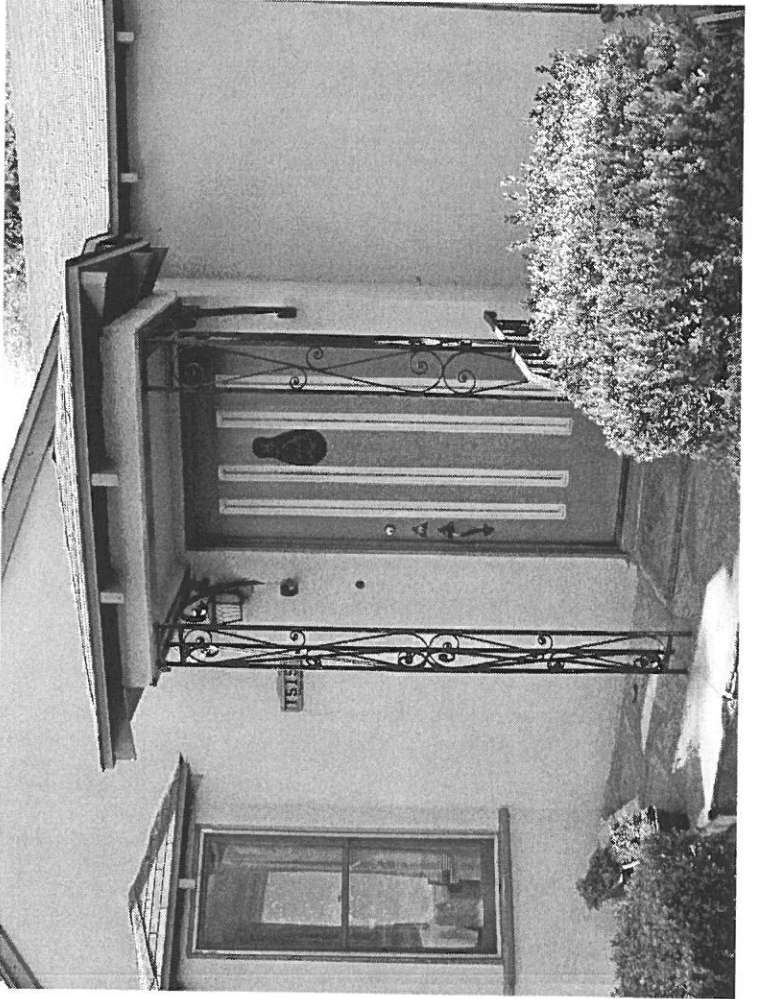
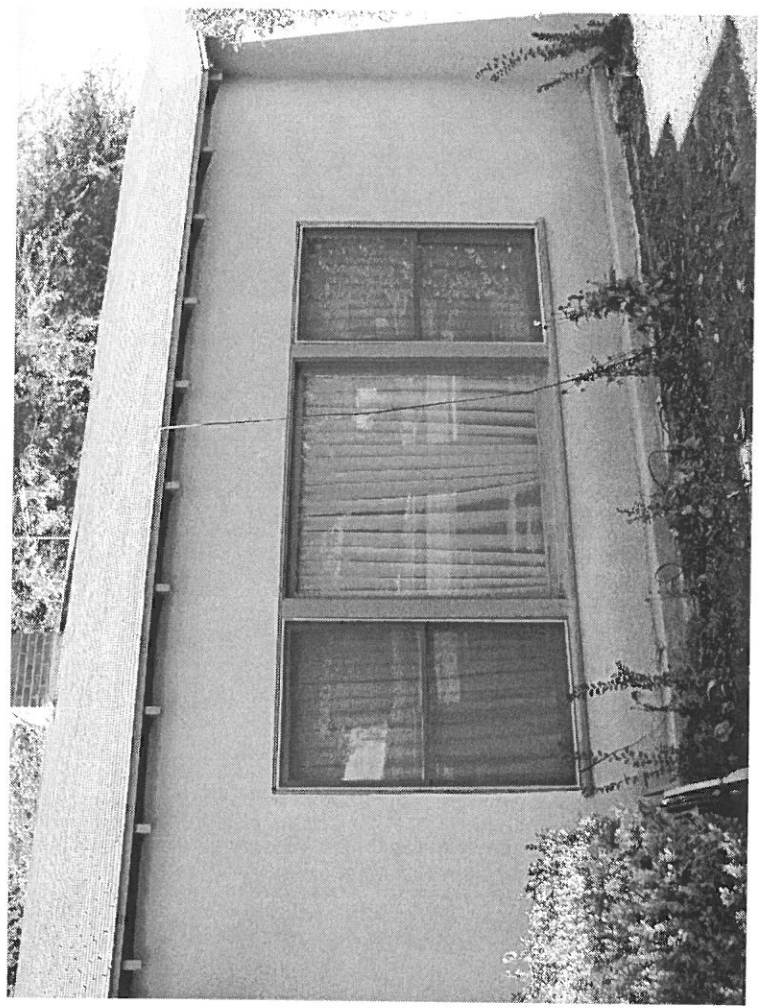
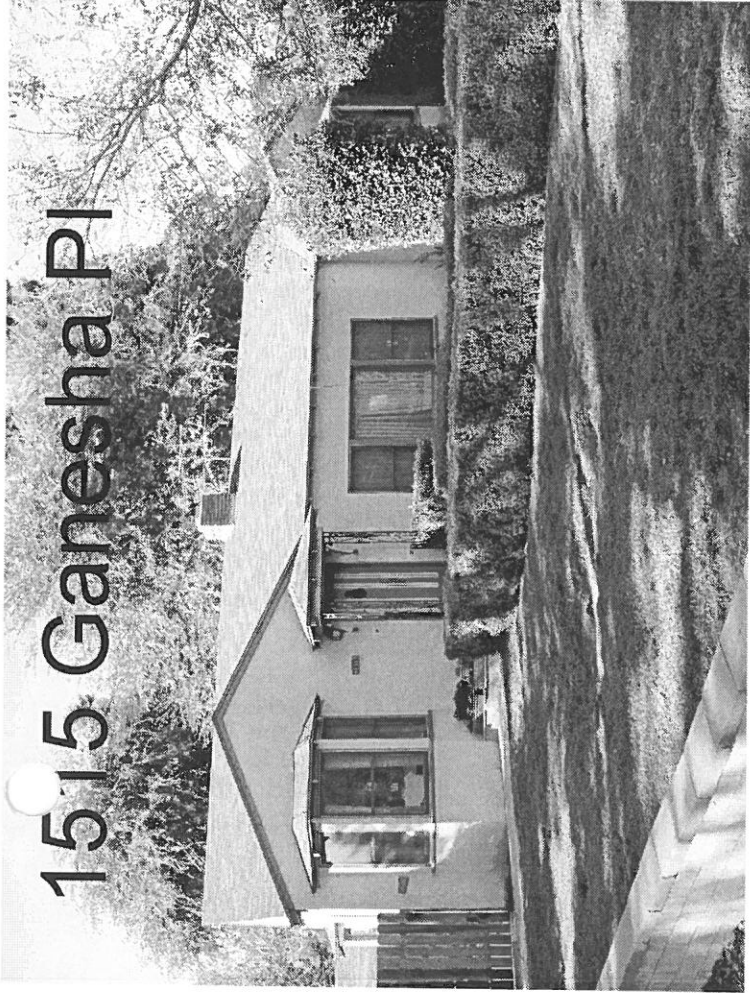
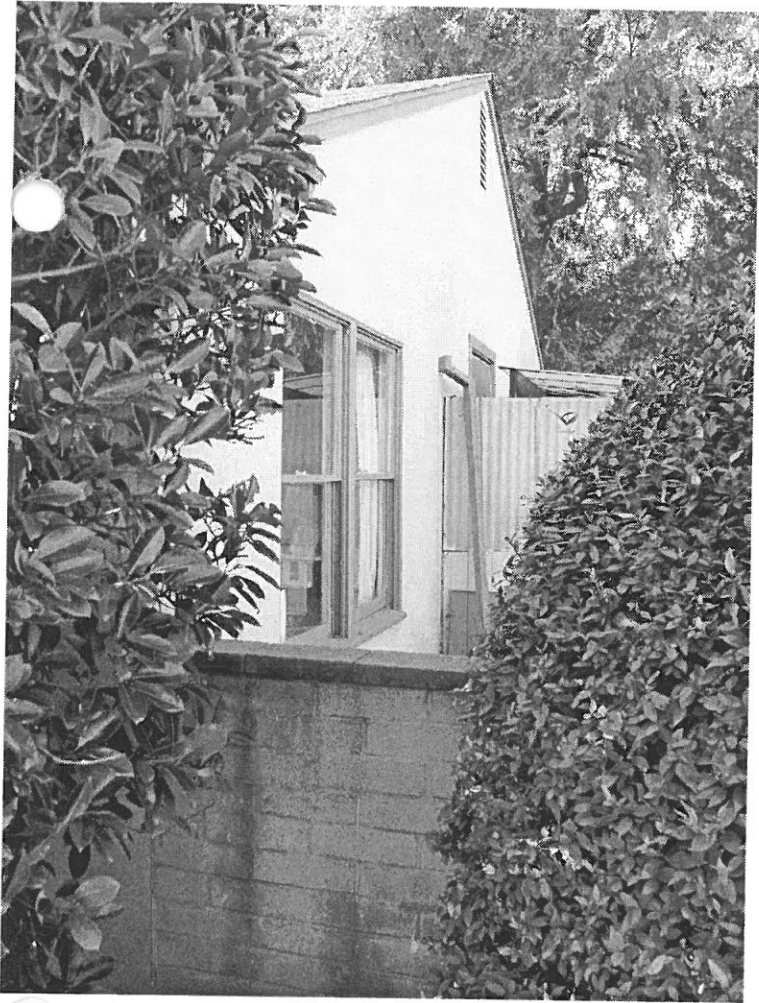
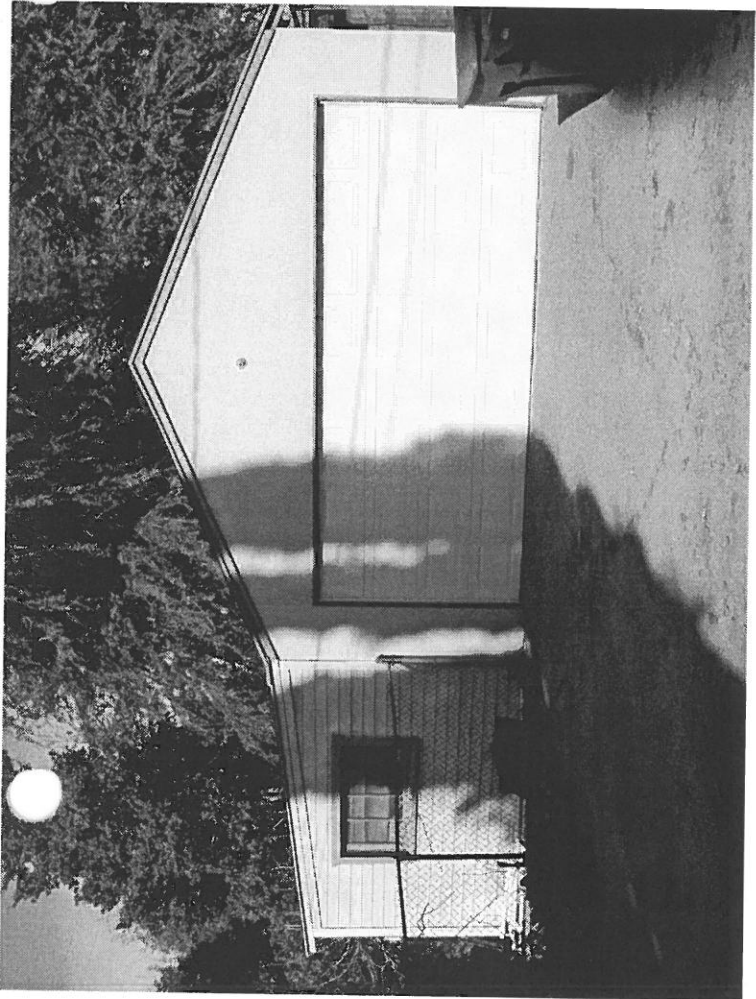
1515 Ganesha Pl

This Minimal Traditional is a rectangular form with two front cross-gables. There are two original bump-out bay windows and one center picture window. Windows are single-paned double-hung. Front porch is simple covered entryway with iron supports. Front door and iron door knocker are original. Wall cladding is smooth stucco. Garage is detached, with modern roll-up door.
