# 16 PRESERVATION BRIEFS

## The Use of Substitute Materials on Historic Building Exteriors

National Park Service  
U.S. Department of the Interior  
Technical Preservation Services

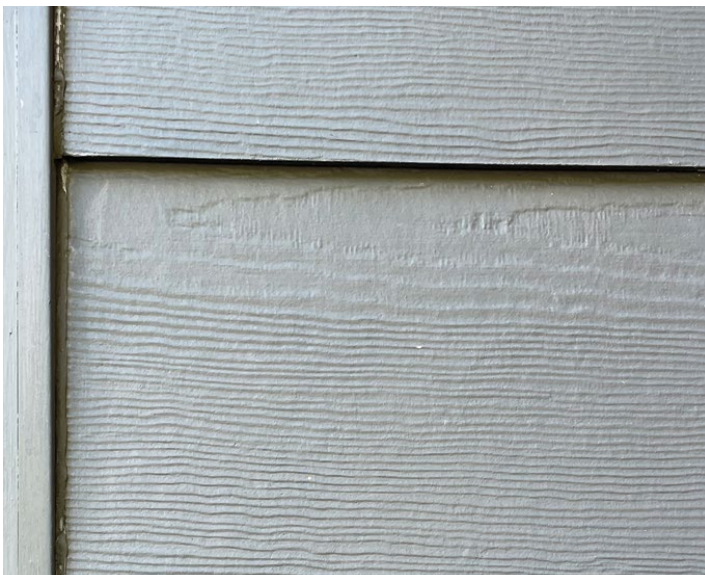
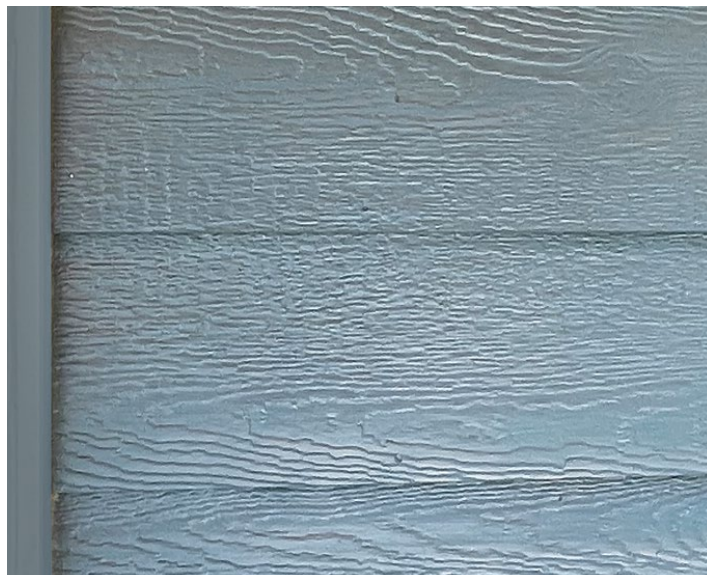
Figure 14. Surface texture is an important aspect in matching the appearance of a historic material, especially when a material is viewed at close range. As seen in these two images, many of the substitute materials produced for siding and trim have an embossed wood grain, making them incompatible for replacing historic wood that was typically planed to a smooth surface. Some substitute products are available with a smooth surface as well. Photos: John Sandor, NPS.

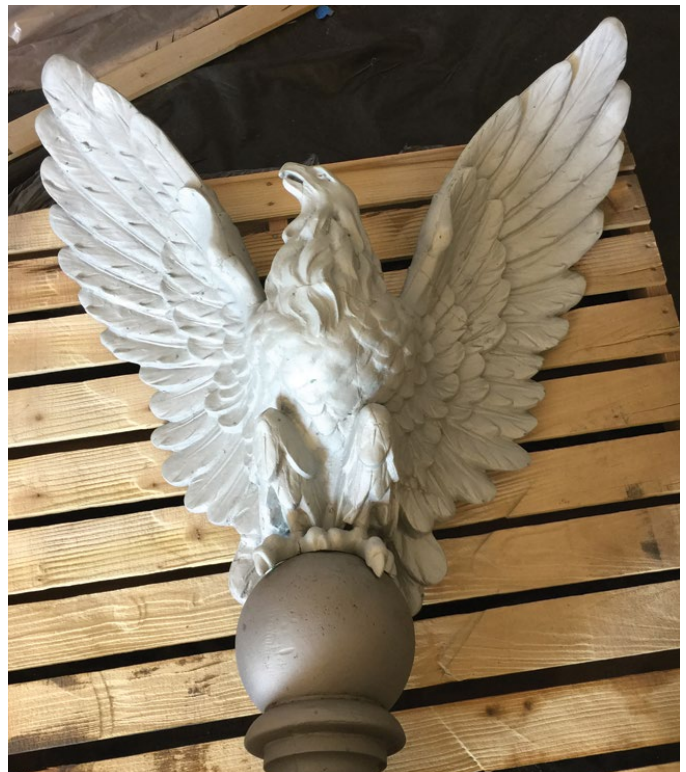
*Figure 16. Aluminum is a highly corrosion-resistant metal that is commonly used as a substitute material for cast iron. Aluminum can be a more affordable and lightweight alternative to cast iron that retains a similar texture, shape, and maintenance cycle. Photo: NPS.*
