Staff Report

City of Pomona Historic Preservation Commission

FILE NO: MAJCOA-000360-2025

A request for a Major Certificate of Appropriateness (MAJCOA-000360-2025) to legalize twenty-four (24) unpermitted vinyl windows on the primary structure of a contributing resource within the Hacienda Park Historic District.

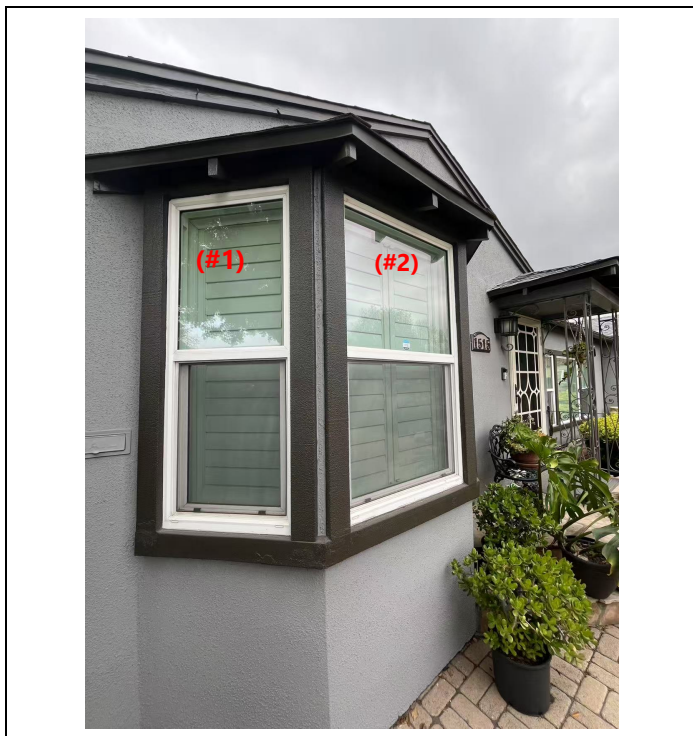
East side windows that near the front door of the main
house dwelling.

___ Excellent ___ Good ___ Fair ___ Poor x Deteriorated to point of being dangerous

The previous wood windows were infested by termites, and they were damaged. Therefore, the previous owner replaced the damaged windows with vinyl materials and wood covered with stucco decorative molding to match the previous windows' style. Also, the previous owner said she has already applied the application and paid for the city's fees for the replacement, so the windows should be legal.

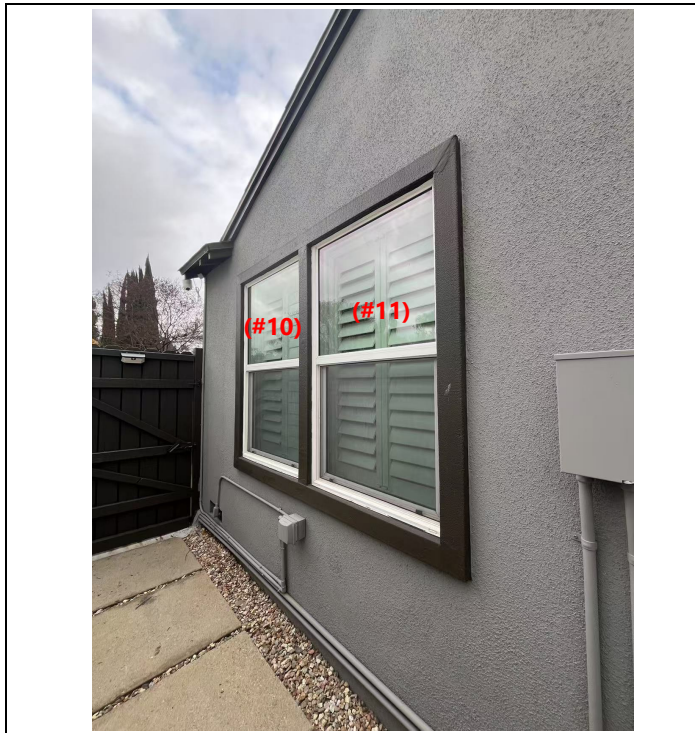
North side windows of the main house dwelling.

☐ Excellent ☐ Good ☐ Fair ☐ Poor ☒ Deteriorated to point of being dangerous

The previous wood windows were infested by termites, and they were damaged. Therefore, the previous owner replaced the damaged windows with vinyl materials and wood covered with stucco decorative molding to match the previous windows' style. Also, the previous owner said she has already applied the application and paid for the city's fees for the replacement, so the windows should be legal.

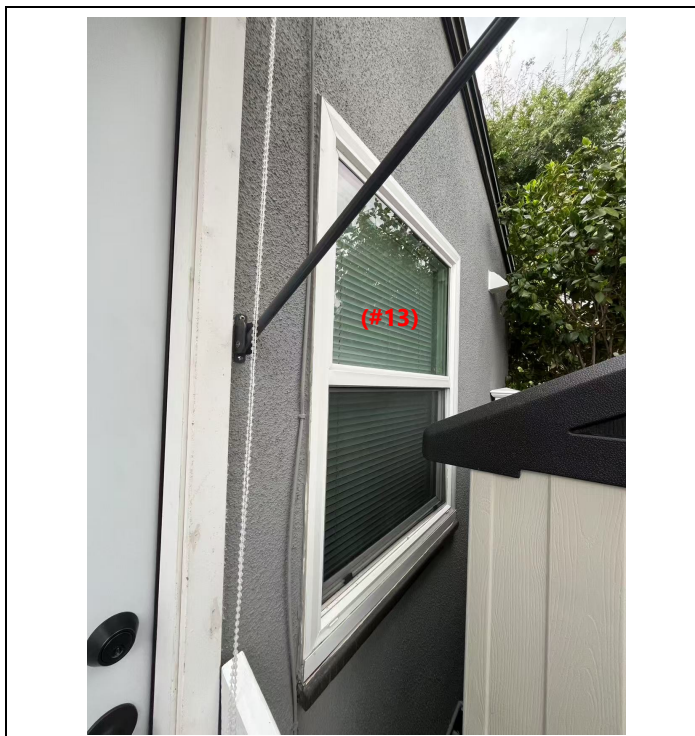
North side windows of the main house dwelling.

x Deteriorated to point of being dangerous

The previous wood windows were infested by termites, and they were damaged. Therefore, the previous owner replaced the damaged windows with vinyl materials and wood covered with stucco decorative molding to match the previous windows' style. Also, the previous owner said she has already applied the application and paid for the city's fees for the replacement, so the windows should be legal.

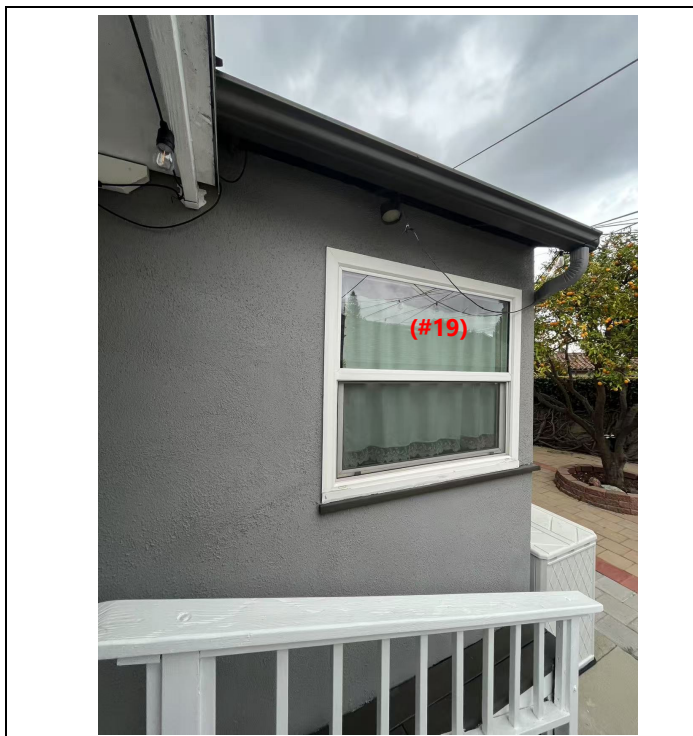
West side windows of the main house dwelling.

x Deteriorated to point of being dangerous

The previous wood windows were infested by termites, and they were damaged. Therefore, the previous owner replaced the damaged windows with vinyl materials and wood covered with stucco decorative molding to match the previous windows' style. Also, the previous owner said she has already applied the application and paid for the city's fees for the replacement, so the windows should be legal.

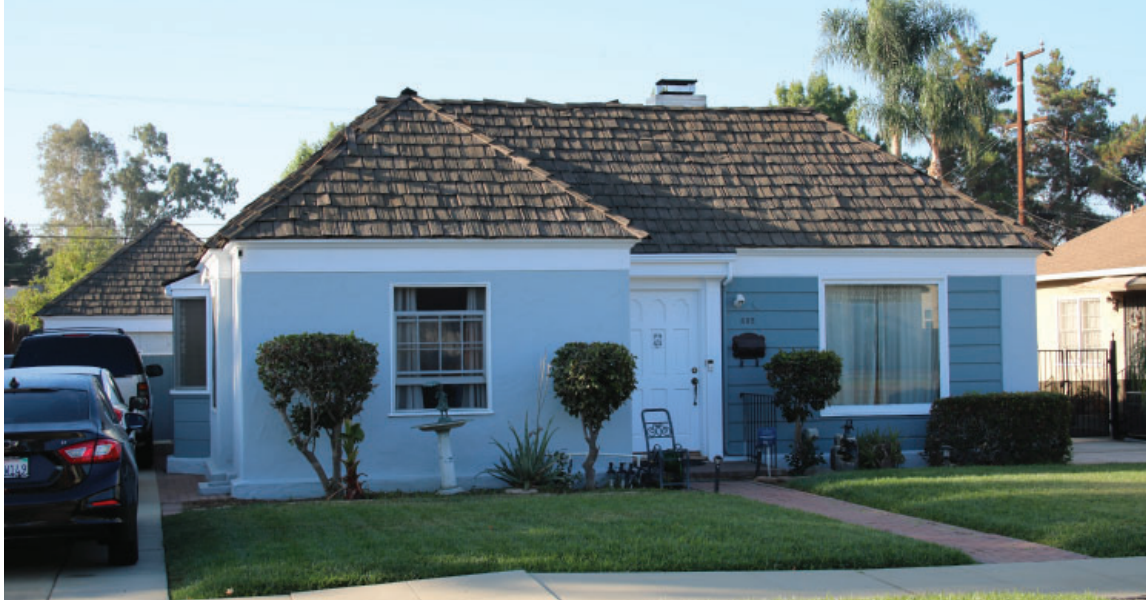
MINIMAL TRADITIONAL ARCHITECTURE

CHARACTER-DEFINING FEATURES

- Cross gable roof
- Front gable end
- Siding or brick were common exterior materials
- Small front porch
- Decorative details on windows, typically shutters

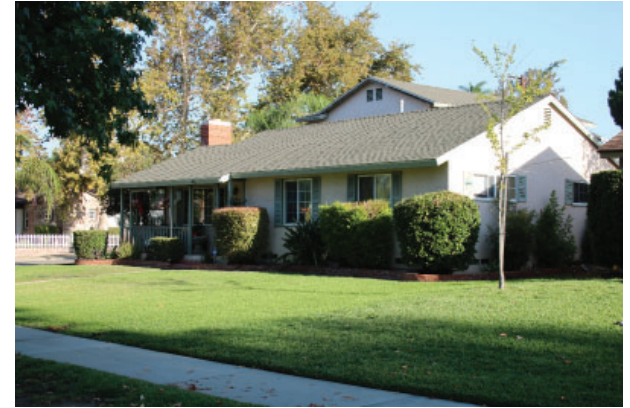
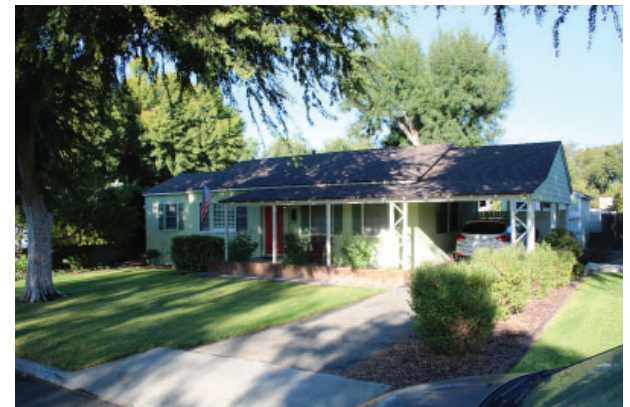
FENCES AND WALLS

- Simple wood fences
- Fences separate front yard from side and rear yards
- Separates formal public view and private space
- Not in front yard.
