State of California - The Resources Agency  
DEPARTMENT OF PARKS AND RECREATION

PRIMARY RECORD

\*Resource Name or #: (Assigned by Recorder) 1515 GANESHA

c. Address 1515 GANESHA \_\_\_\_\_ City: Riverside \_\_\_\_\_ Zip \_\_\_\_\_

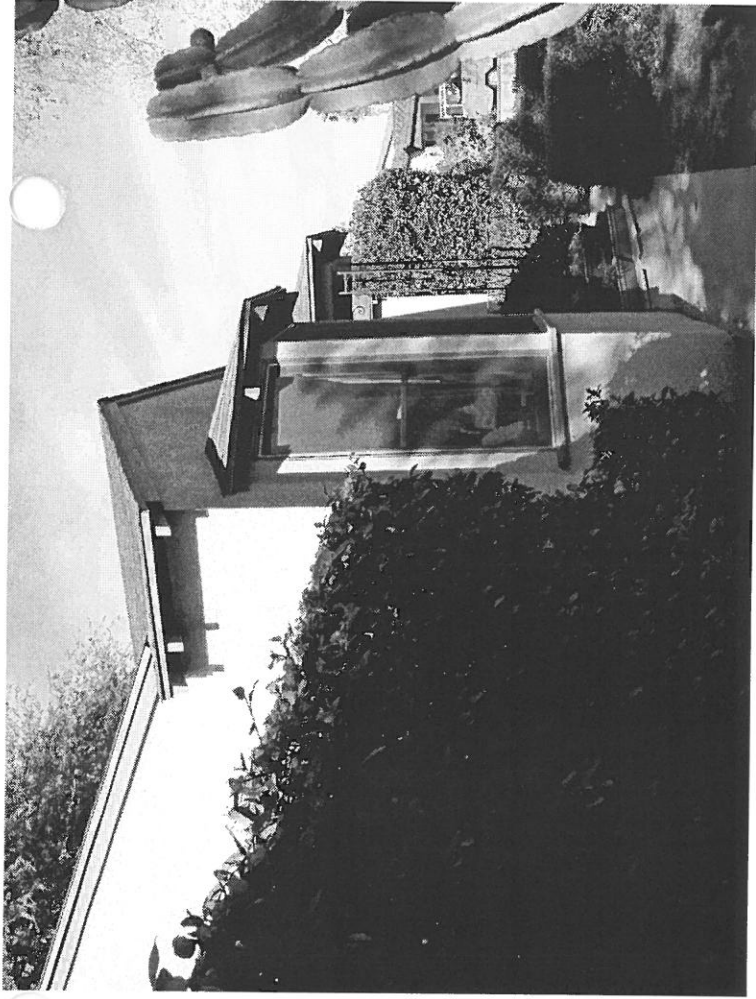
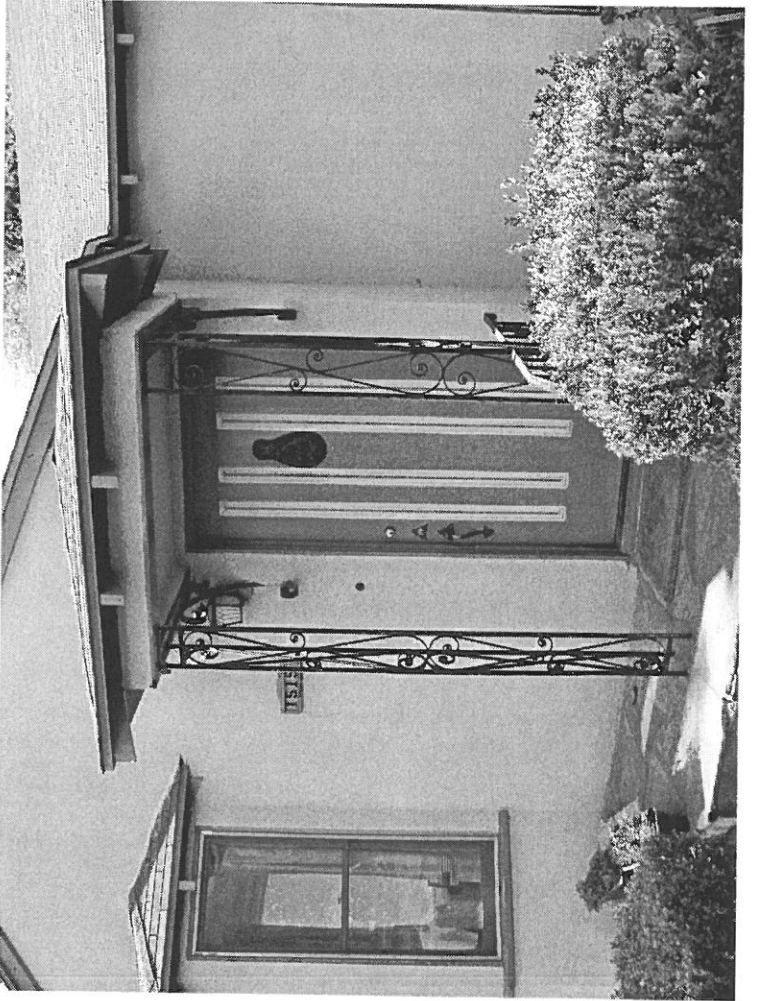
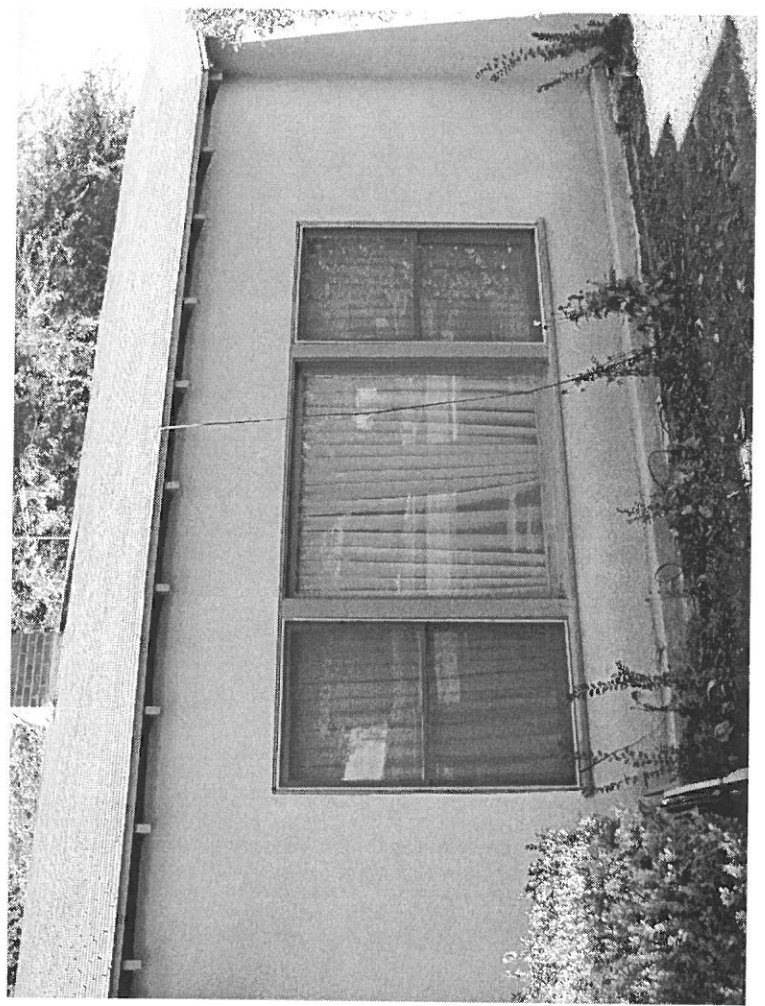
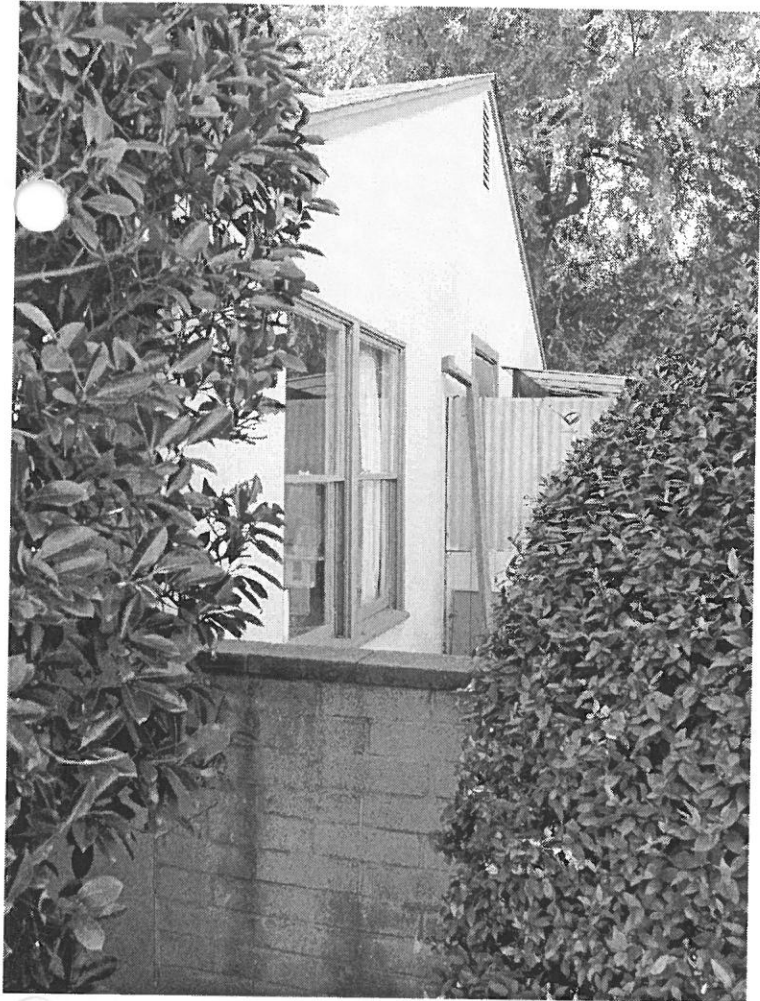
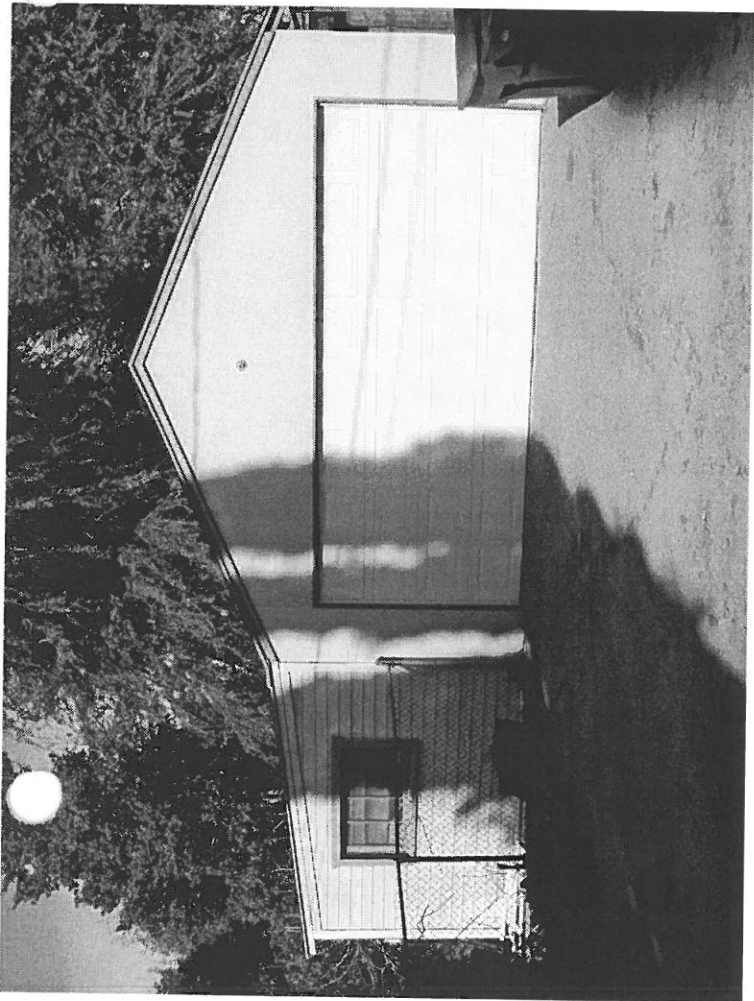
1515 Ganesha Pl

This Minimal Traditional is a rectangular form with two front cross-gables. There are two original bump-out bay windows and one center picture window. Windows are single-paned double-hung. Front porch is simple covered entryway with iron supports. Front door and iron door knocker are original. Wall cladding is smooth stucco. Garage is detached, with modern roll-up door.
