Historic Preservation Application

WINDOW ASSESSMENT FORM

Description of Project – Front Living Room Window (#1)

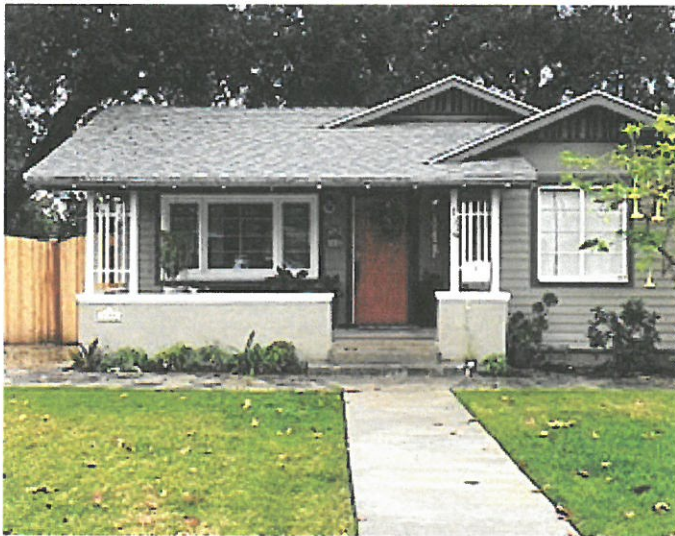
Before

Window Description: Single pane,
casement window - one on each side
of the main window, horizontal pane
design, wood stool, apron & sill.
Some of the muntins have rusted
and was painted over. Surface
of grilles/muntins was bumpy, cracking,
and uneven in appearance.

- I wanted to have functional windows that could properly be opened and closed from the inside of the home. The window cranks on each side of the main window were damaged and not working properly. The windows could be unlocked from the inside of the home; however, the cranks were inoperable, not allowing the windows to be opened unless pushed out. To close the window, one would have to go outside of the home, push the window closed, then locked on the inside for safety/security.

- My intent was to keep the window grid style the same so as not to change the look of the windows. I went so far as to get casement windows (with horizontal muntins) with crank handles.
- The size of the window remained the same. The windowsill was not changed, removed, or replaced. Windows now have screens to allow for ventilation without insects entering into the home.

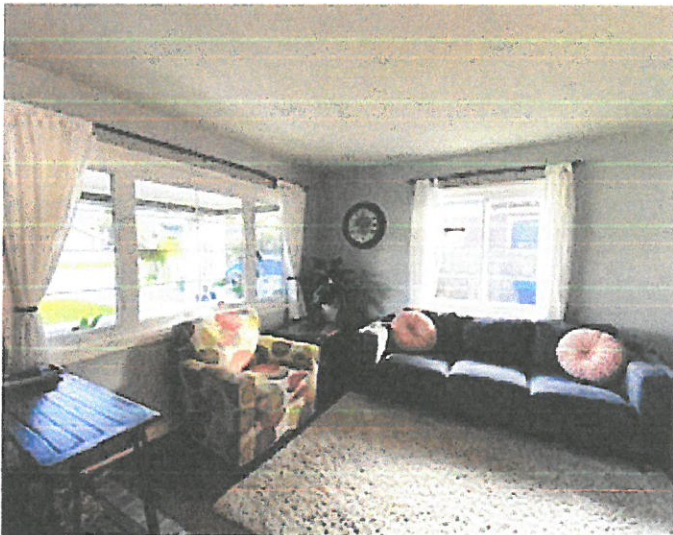
Before

Window Description: Single paned, one casement window. Horizontal pane. Wood stool, apron and sill. Grilles were rusted and painted over leaving surface bumpy and uneven.

- I was also concerned that the window frame would crack or break if pressure was placed on the frame of the window when attempting to open it due to the existing rust and cracks.

- My intent of removing and replacing the window was to keep the look the same, like for like, with the difference being replacing the single paned window with a double paned window to keep costs down and noise to a minimum.
- The size of the window remained the same. The windowsill was not changed, removed, or replaced.
- Window screens were installed for ventilation and to keep insects (especially the flies) out while the windows were open. There were no window screens on the windows upon purchase of the home.
