To: Farook Zia
From: Javier Cabral / Consulting Arborist
Date: October 20, 2021
Subject: 1137 & 1149 Philips Ranch Rd.

1137 & 1149 W. Philips Ave Pomona, CA 91766

Table of contents

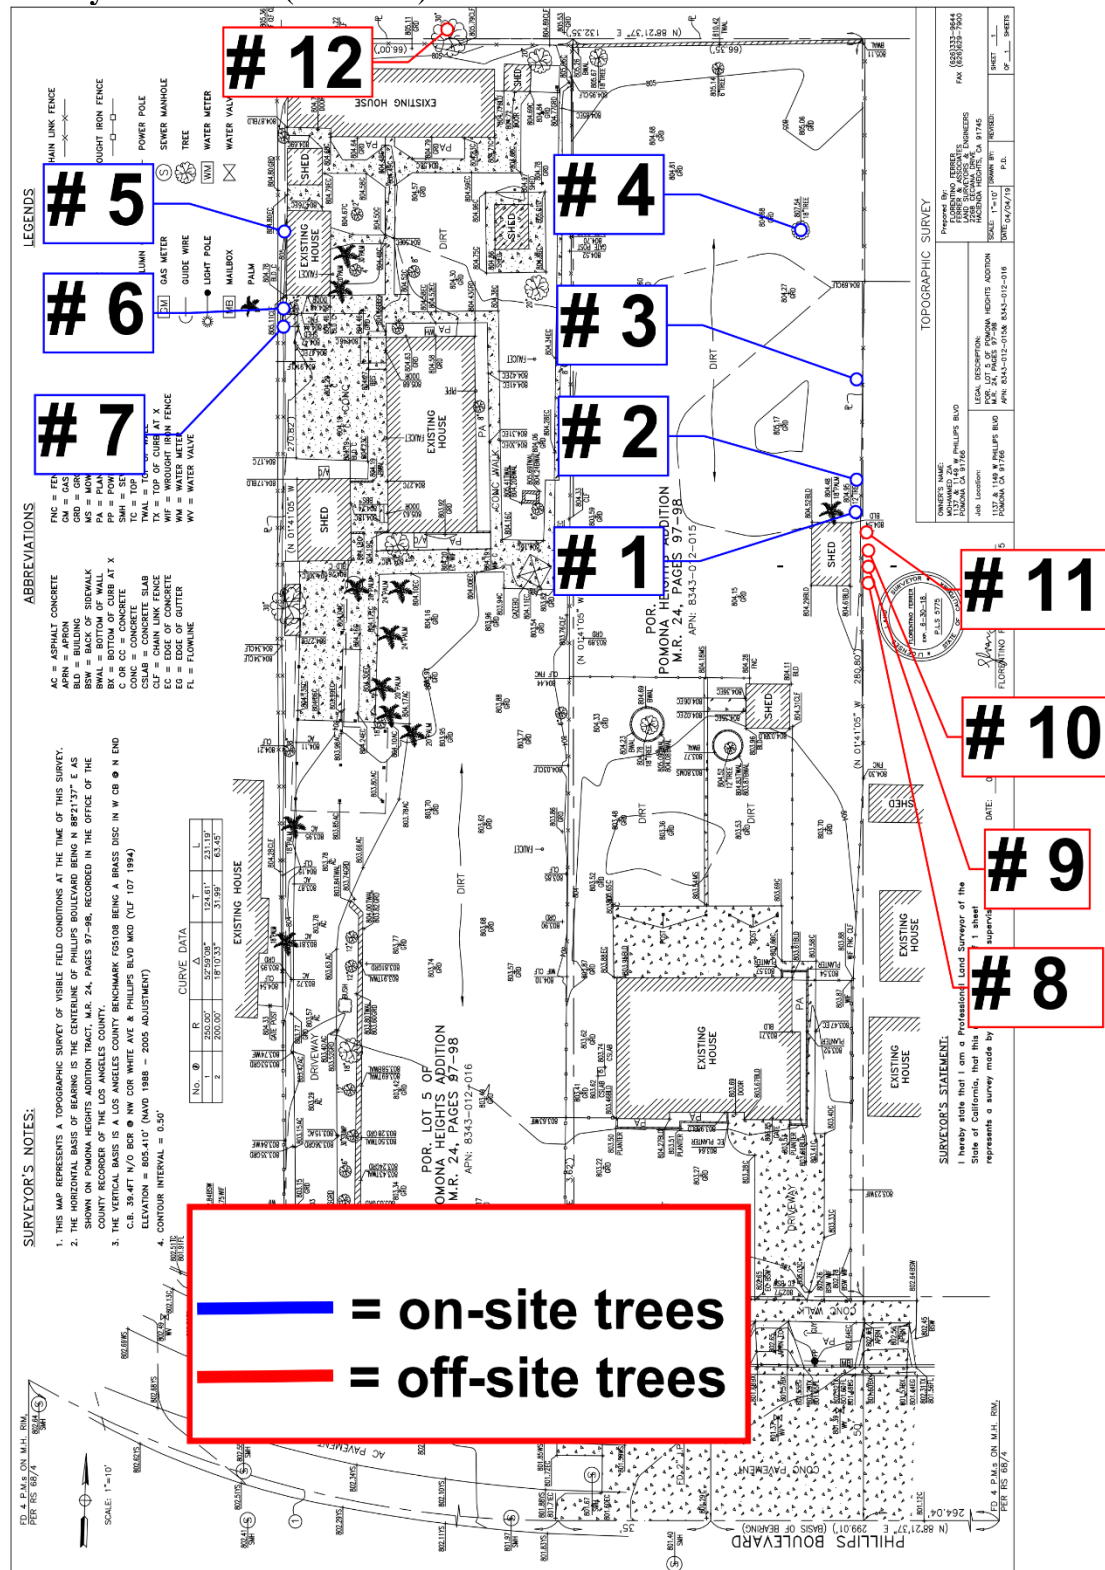
Trees # 1 & 2 (facing east)

Tree #	Common Name	Botanical Name	Diameter at 4.5 feet (dbh) In inches	Height (in feet)	Spread (in feet)	Physiological condition	Protection status	REMOVE or Remain	Comments
1	Evergreen ash	<i>Fraxinus uhdei</i>	multi 1+2+3	12	5	good	no	REMOVE	growing against fence
2	Tree of heaven	<i>Ailanthus altissima</i>	multi 1+2++2+2	20	21	good	no	REMOVE	growing against fence
3	Coast live oak	<i>Quercus agrifolia</i>	multi 1+1+4	12	6	good	no	REMOVE	growing against fence
4	Coast live oak	<i>Quercus agrifolia</i>	multi 3+7+10+11	12	5	good	mature significant	REMOVE	This Oak tree is to be removed because the trunk sits in the footprint of the rear unit and it cannot be saved
5	Coast live oak	<i>Quercus agrifolia</i>	6	18	12	poor	no	REMOVE	growing against wall & girdled post
6	Coast live oak	<i>Quercus agrifolia</i>	10	25	8	poor	mature significant	REMOVE	growing against wall & girdled post
7	Tree of heaven	<i>Ailanthus altissima</i>	multi 3+4	20	8	poor	no	REMOVE	trunk damage
