## SPANISH COLONIAL REVIVAL

# SPANISH COLONIAL REVIVAL ARCHITECTURE

The Pomona Guide to Historic Preservation

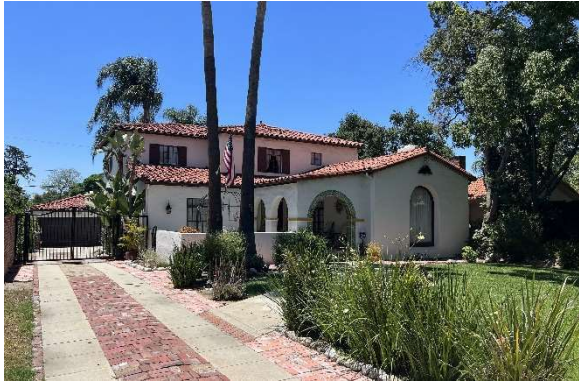
*130 Garfield Avenue (1928; Lincoln Park Historic District).*

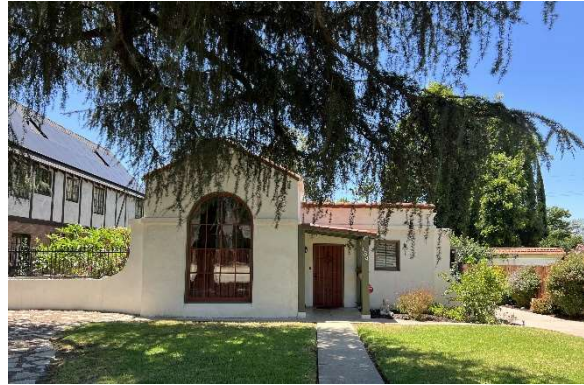
*184 Garfield Avenue (1924; Lincoln Park Historic District).*

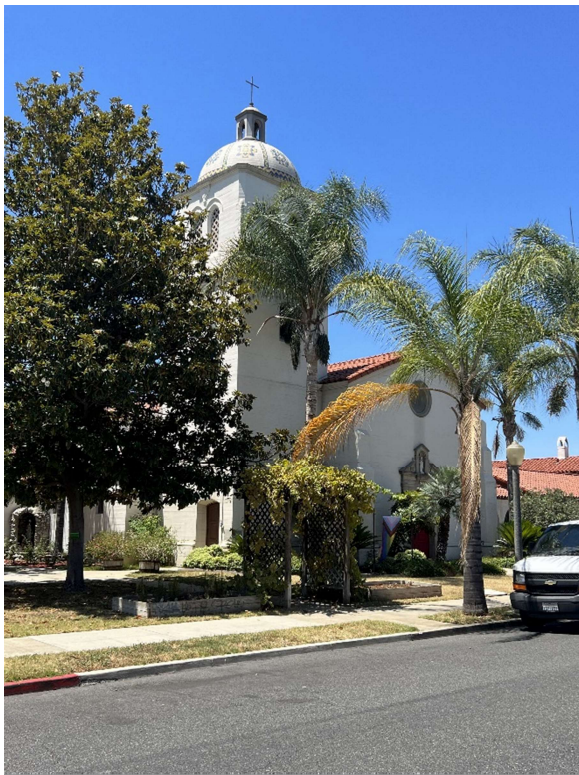
*St. Paul Episcopal Church, 260 E. Alvarado Street (1930; Lincoln Park Historic District).*

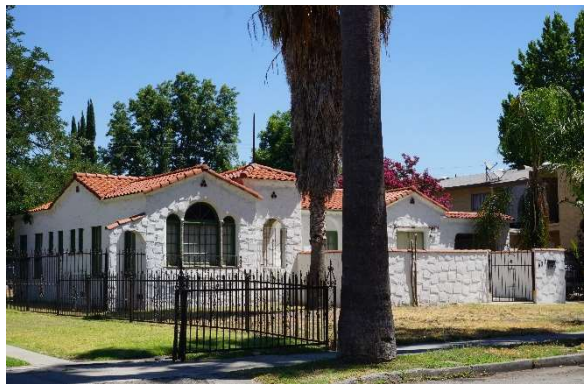
*637 San Francisco Avenue (1937).*

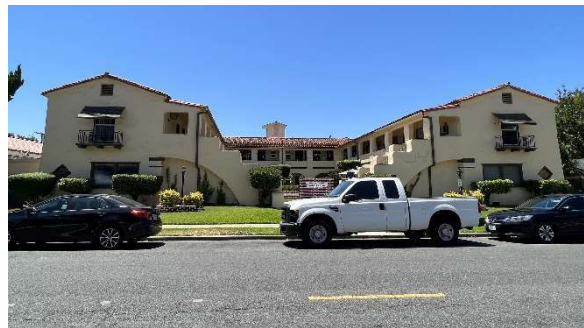
*206 E. Alvarado Street (1928).*
