NUMBER 52

## Interpreting The Secretary of the Interior's Standards for Rehabilitation

### Subject: Incorporating Solar Panels in a Rehabilitation Project

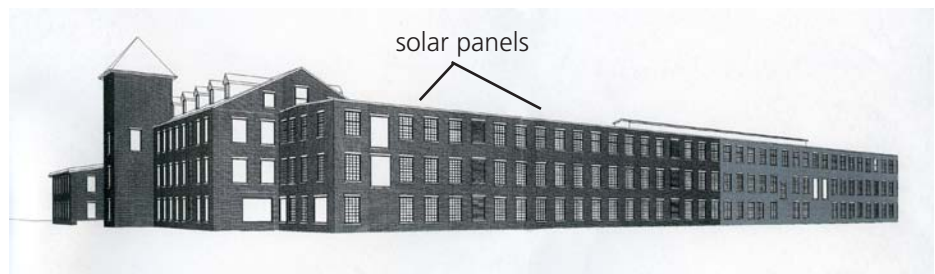
*Because of the size of this historic mill, a large array of solar panels could be installed on the flat roof without being seen from the ground.*

The rehabilitation of this mid-nineteenth century mill incorporated a large, roof-mounted photovoltaic installation. Although the historic building does not have a parapet wall at the roofline, the height of the building and the arrangement of the panels render the entire installation invisible from the ground. It is important to note that the panels are placed horizontally. Had the panels been installed with a vertical tilt, the angle required to maximize efficiency would have caused the panels to extend significantly higher above the roof. Simply changing the direction in which the panels are tilted can affect their visibility and reduce their impact on the character of the historic property.

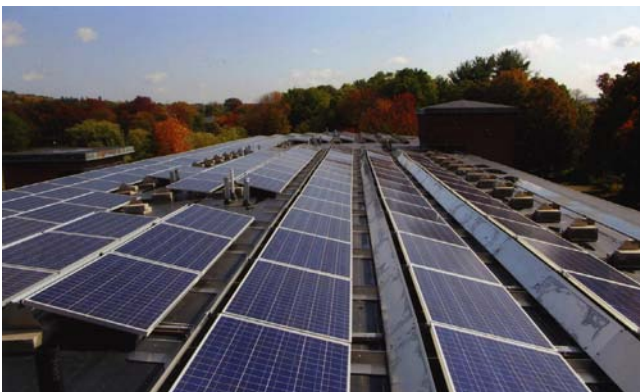
*Solar panels installed on the flat roof.*

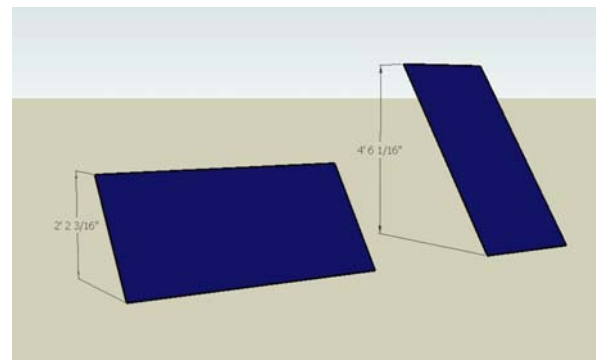
*By placing the panels horizontally, the overall height of the installation and its visibility is reduced.*

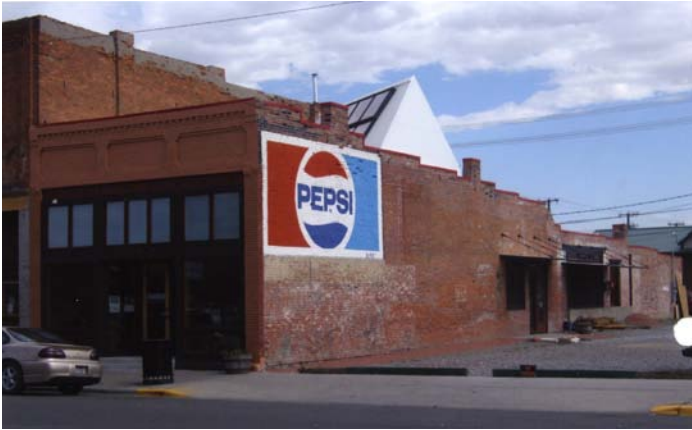
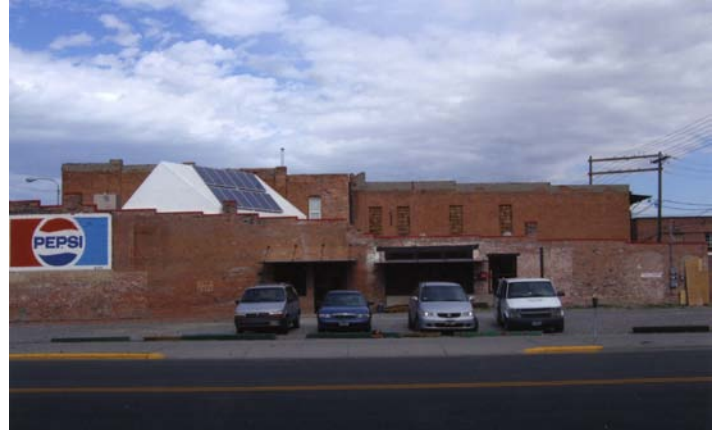
*The addition of a large rooftop monitor featuring skylights on the front slope and solar panels on the rear slope is not compatible with the historic character of this small, one-story commercial building.*

**Application 2 (*Incompatible treatment*):** During the rehabilitation of this late-nineteenth century commercial building, a conspicuous rooftop monitor with prominent solar panels and skylights was constructed on the one-story structure. The size and finish of this rooftop addition are incompatible with the historic character of the building. However, the building could have accommodated both skylights and solar panels if they had been installed differently. An alternative design that could have met the Standards would have included low-profile skylights and solar panels concealed behind the parapet wall.

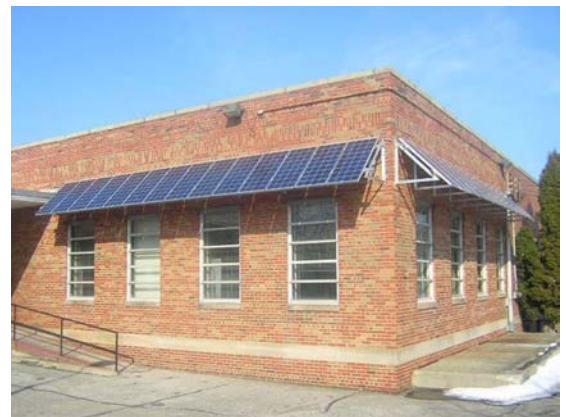
*Above: Shown from the rear of the property, these solar panels serve a secondary function as awnings to shade south-facing windows. Because of their location at the back of the building immediately adjacent to a loading dock, the installation of these panels does not affect the historic character of the property.*

**Application 3 (*Compatible treatment*):** The rehabilitation of this historic post office incorporated solar panels as dual-function features: generation of electricity and shading for south-facing windows. In this instance, the southern elevation of the building is also a secondary elevation with limited visibility from the public right of way. Additionally, because this area of the building is immediately next to the post office's loading dock, it has a more utilitarian character than the primary facades and, therefore, can better accommodate solar panels. Because the panels are in a suitable location at the rear of the property and are appropriately sized to serve as awnings, they do not affect the overall historic character of the property. Additionally, a screen of tall plantings shields the solar panels from view from the front of the building, further limiting their visibility.

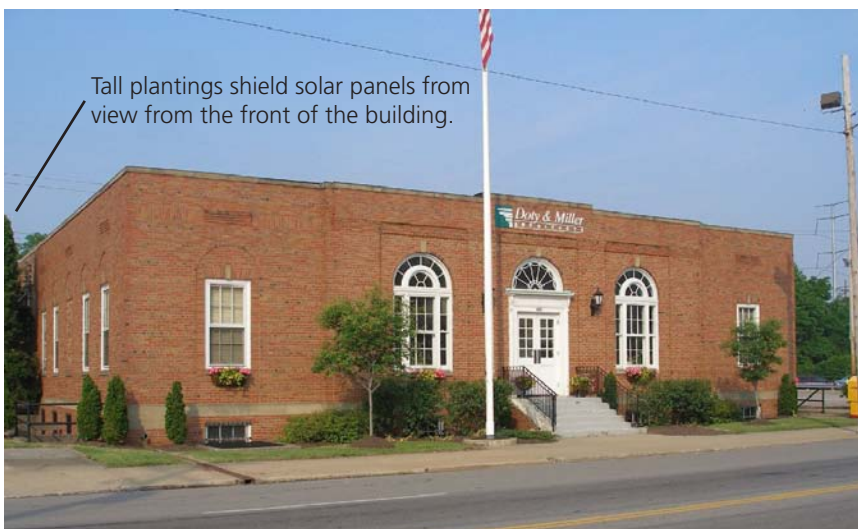
*Left: The solar panels are not visible from the front of the building. Additionally, even if the vegetation were removed, the installation would only be minimally visible along an alley at the rear of a secondary side elevation.*
