CRAFTSMAN

1911

CITY OF POMONA
Historic Resources Inventory
(Short Form - Exterior)

(1) Address: ^{NORTH} 1395 Palomares

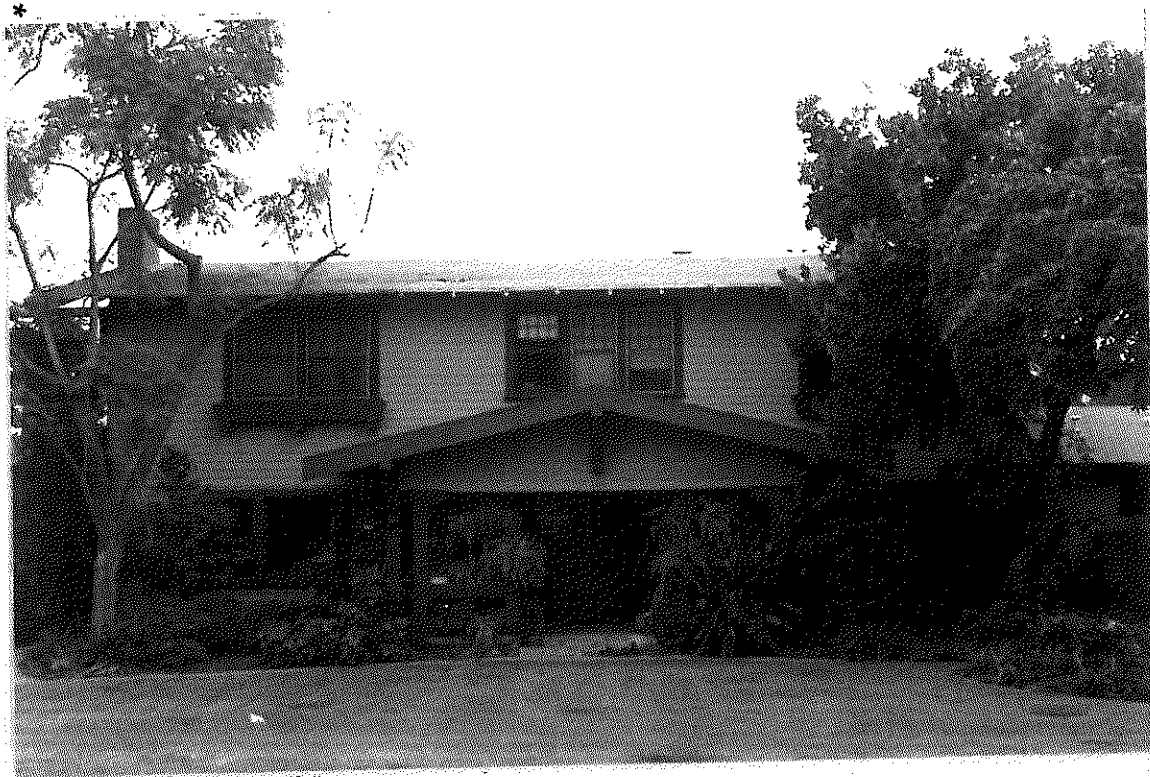
The expansive diagonal placement of this large Craftsman adds to its elegant stature. The wide clapboards, multi-paned double-hung window, second floor planters, and two-story rectangular shape all contribute to the Colonial character of this house. The main roof is a single, low-pitched transverse gable while the wide front porch has a similar front-facing gable. The prominent front porch is Oriental in flavor with a wide bargeboard and heavy, angular, triple porch posts and railings. The heavy eaves support brackets add to this influence. A pergola on the right side is covered with wisteria, and is typical of the Craftsman period, an era which featured outdoor living and lush plantings. The original placement of the pergola was in front of the home.

(6) Condition of Structure: Very Good
