## CRAFTSMAN BUNGALOW

1911

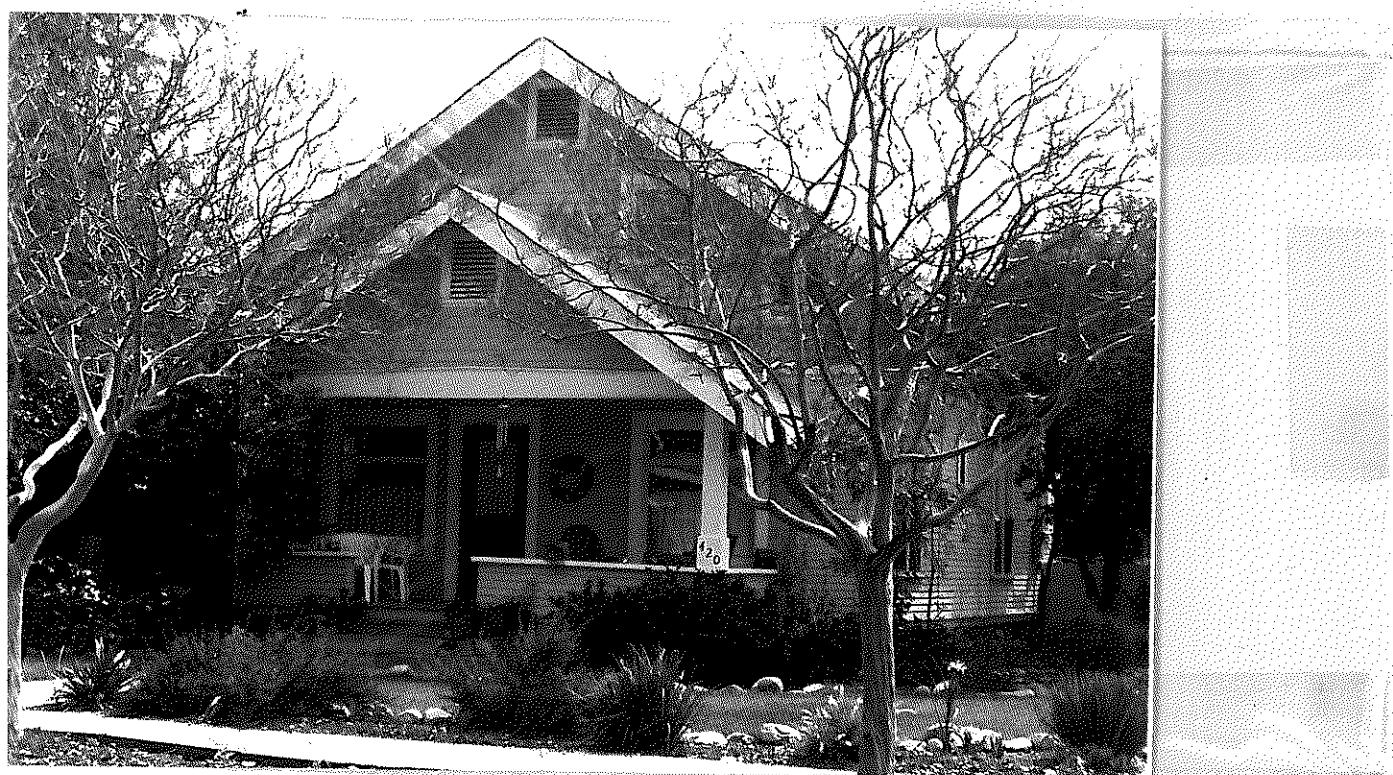
This attractive, clean-lined house is a beautiful example of the Craftsman Bungalow. The double-gabled roof lends visual interest to the front of the house and enhances the box-like structure of the house. The decorative air vents set off each gable roof line. Clapboard siding is present. Two large windows on the front porch are surrounded by broad window frames. The front door has the same broad frames. The front gable covers the front porch and is supported by squared wood columns at the corners. A fieldstone foundation supports the structure.
